## General Information

| Make | Toyota | Model | Vios |
| YOM | 2024 | Mileage | 7,883 |
| Registration No. | EAG6841 | Chassis No. | PA1B18F38P4236814 |

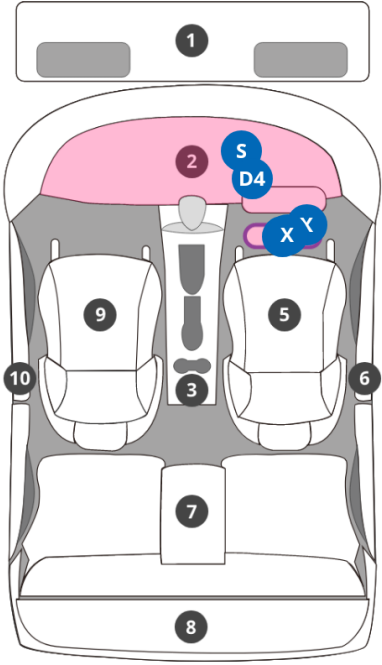
| Interior Evaluation : <span style="color: red;">C</span> | Exterior Evaluation : <span style="color: red;">C</span> |
|---|---|
| <b>Remarks</b><br>Overall Interior - Smell - Yes / (R) Front Floor Mat - Missing - Yes / (L) Front Floor Mat - Missing - Yes / Mat Other - Missing - Yes / Glove Box - Loose, Deformed - Large | <b>Remarks</b><br>(L) Front Door, Molding - Scratch & Dent - Small / (L) Rear Door, Molding - Scratch - Minimal / Rear Bumper, Lamps, Panels - Scratch - Large / (R) Rear Door, Molding - Scratch & Dent - Large / (R) Front Door, Molding - Scratch & Dent - Small / (R) Mirror - Scratch, Peeled - Minimal / Front Bumper, Grille, Lamps - Crack, Gap - Medium / Trunk Hood, Rear Gate - Scratch & Dent - Medium / (R) Rear Fender, Molding - Scratch & Dent - Medium |
