## General Information

| Make | Toyota | Model | Vios |
| YOM | 2024 | Mileage | 23,588 |
| Registration No. | GBE2394 | Chassis No. | PA1B18F30R4248121 |

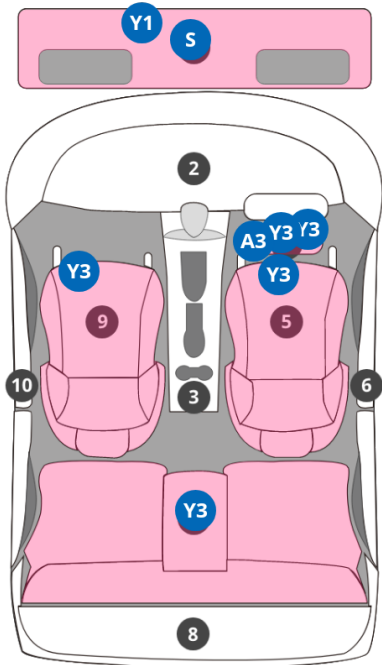
| Interior Evaluation : <span style="color: red;">C</span> | Exterior Evaluation : <span style="color: red;">D</span> |
| <p><b>Remarks</b></p> <p>(R) Front Seat - Grime - Medium / (R) Front Floor Mat - Grime - Medium / Rear Seat - Grime - Medium / Mat Other - Grime - Medium / (L) Front Seat - Grime - Medium / (L) Front Floor Mat - Cut, Crack - Medium / Overall Interior - Smell - Yes / Ceiling - Grime - Minimal</p> | <p><b>Remarks</b></p> <p>(R) Rear Door, Molding - Scratch &amp; Dent - Minimal / Bonnet, Headlight - Scratch &amp; Dent - Small / (L) Front Door, Molding - Scratch &amp; Dent - Medium / (L) Mirror - Scratch - Medium / Front Bumper, Grille, Lamps - Scratch &amp; Dent - Large / (L) Front Fender, Molding - Dent - Small / (R) Mirror - Scratch - Minimal / (R) Front Door, Molding - Scratch &amp; Dent - Small / Rear Bumper, Lamps, Panels - Scratch - Medium / (L) Rear Fender, Molding - Scratch - Small / (R) Mirror - Crack - Damaged</p> |
