General Information

Make	Toyota	Model	Vios
YOM	2024	Mileage	10,628
Registration No.	CCA8796	Chassis No.	PA1B18F36R4257079
CC	1.3	Transmission	CVT
Fuel Type	Gas	Type of Body	Sedan
Colour	Silver

Body / Panel Condition

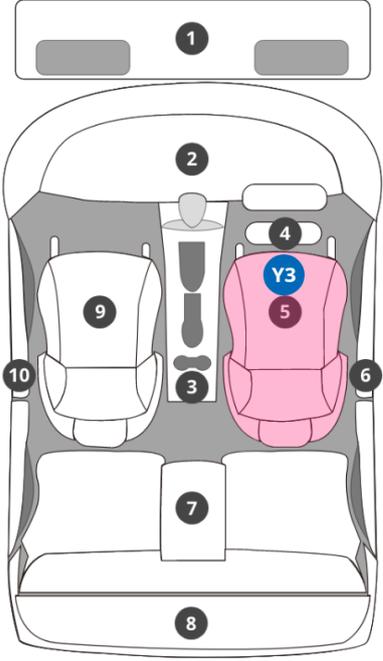
<p>a : Cut, Fray d : Loose, Deformed k : Animal Hair s : Smell t : Cigarette Burns x : Defective y : Stain</p>

<p>A : Scratch AU : Scratch & Dent B : Modified C : Corrosion G : Stone chip P : Faded S : Rust SC : Rust & Corrosion U : Dent X : Defective Y : Crack, Gap</p>
Remarks (R) Front Seat - Grime - Medium	Remarks Front Bumper, Grille, Lamps - Scratch - Minimal
Frame Evaluation : A	Functional Evaluation : B
Remarks Defects not found	Remarks Battery - Weak - Yes / Spare Key - Issue - Unexist
