## General Information

| Make | Toyota | Model | Vios |
| Registration No. | NHM9745 | Chassis No. | PA1B18F30R4241489 |

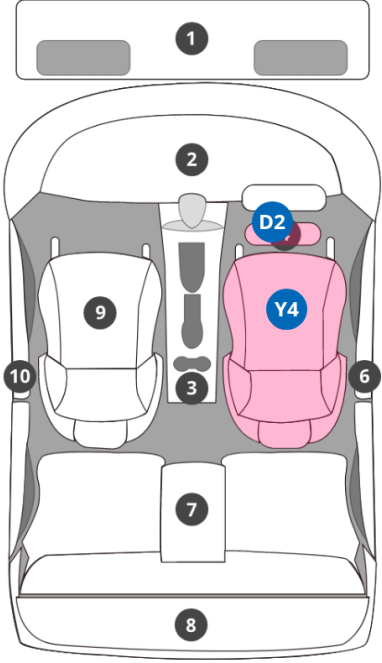
| Interior Evaluation : <b>C</b> | Exterior Evaluation : <b>D</b> |
| <b>Remarks</b><br>(R) Front Seat - Grime - Large / (L) Front Floor Mat - Worked - Small | <b>Remarks</b><br>Rear Bumper, Lamps, Panels - Scratch & Dent - Large / (R) Rear Fender, Molding - Scratch - Medium / Front Bumper, Grille, Lamps - Scratch - Large / Bonnet, Headlight - Scratch - Large / (L) Rear Door, Molding - Scratch - Small / (L) Front Door, Molding - Scratch - Minimal / (L) Rear Fender, Molding - Scratch - Small / Trunk Hood, Rear Gate - Crack, Gap - Medium |

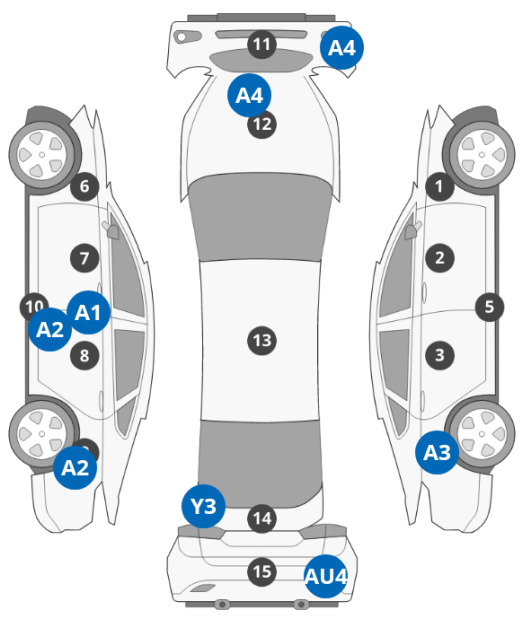
| Inspector Notes |
|---|
| with warranty booklet and spare tire/ with LTO plate/ no jack and tools/ broken tail light and rear reflector/ |
