## General Information

| Make | Toyota | Model | Avanza |
| YOM | 2024 | Mileage | 54,404 |
| Registration No. | NHR6817 | Chassis No. | MHFAA1BY7P0020075 |

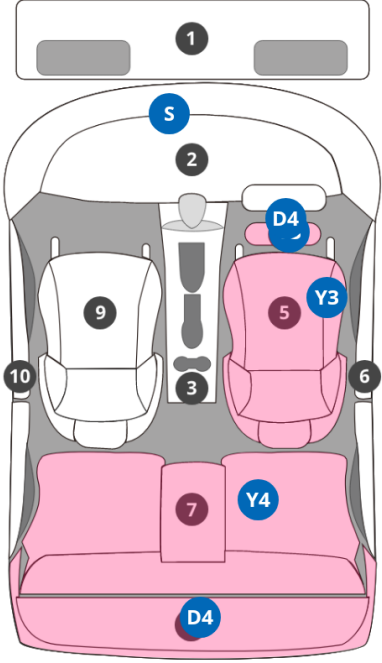
| Interior Evaluation : <span style="color: red;">C</span> | Exterior Evaluation : <span style="color: red;">E</span> |
| <b>Remarks</b><br>(R) Front Floor Mat - Grime - Medium / (R) Front Seat - Grime - Medium / Rear Seat - Grime - Large / Trunk Room - Worked - Large / (L) Front Floor Mat - Worked - Large / Overall Interior - Smell - Yes | <b>Remarks</b><br>(L) Rear Door, Molding - Scratch & Dent - Large / (L) Front Door, Molding - Scratch - Medium / Trunk Hood, Rear Gate - Scratch & Dent - Medium / Rear Bumper, Lamps, Panels - Scratch - Large / (R) Rear Fender, Molding - Scratch - Medium / (R) Rear Door, Molding - Scratch - Medium / (R) Front Door, Molding - Scratch - Large / (R) Front Fender, Molding - Scratch - Large / (L) Front Fender, Molding - Scratch - Small / Bonnet, Headlight - Scratch - Minimal / (L) Mirror - Scratch, Peeled - Minimal / (R) Mirror - Scratch, Peeled - Minimal / Roof - Scratch - Medium |
