## General Information

| Make | Toyota | Model | Raize |
| YOM | 2022 | Odo Meter Reading | 65,940 |
| Registration No. | DAQ9414 | Chassis No. | MHKAB1BA2NJ016718 |

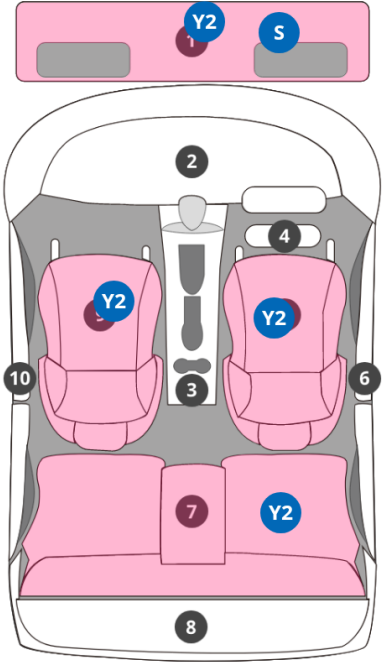
| Interior Evaluation : <span style="color: red;">C</span> | Exterior Evaluation : <span style="color: red;">C</span> |
| <b>Remarks</b><br>Overall Interior - Worn as per age - Yes / Overall Interior - Smell - Yes / Rear Seat - Grime - Small / (R) Front Seat - Grime - Small / (L) Front Seat - Grime - Small / Ceiling - Grime - Small | <b>Remarks</b><br>(L) Front Fender - Repair Traces - Yes / Roof - Repair Traces - Yes / (L) Front Door, Molding - Dent - Small / (L) Rear Door, Molding - Scratch - Small / Rear Bumper, Lamps, Panels - Scratch - Small / Trunk Hood, Rear Gate - Scratch - Minimal / (R) Rear Door, Molding - Scratch & Dent - Medium / (R) Rear Fender, Molding - Scratch - Small / (R) Front Door, Molding - Scratch - Small / (R) Front Fender, Molding - Scratch - Small / (L) Front Fender, Molding - Scratch - Minimal / (L) Rear Fender, Molding - Scratch - Small / Roof - Scratch - Small / Bonnet, Headlight - Scratch - Small / Front Bumper, Grille, Lamps - Scratch & Dent - Small |
