General Information

Make	Toyota	Model	Vios
YOM	2024	Mileage	25,885
Registration No.	NHR3426	Chassis No.	PA1B18F38P4230172
CC	1.3	Transmission	CVT
Fuel Type	Gas	Type of Body	Sedan
Colour	Green

Body / Panel Condition

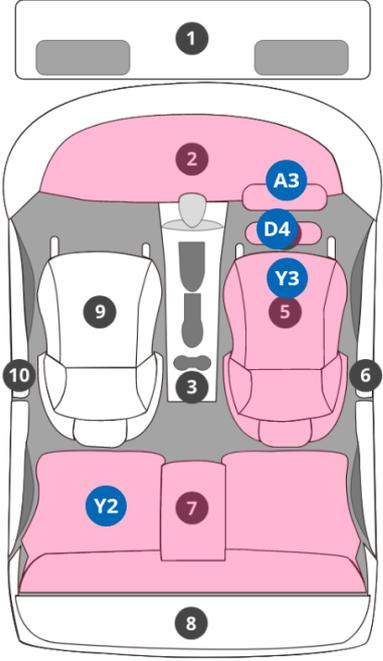
Interior Evaluation : C	Exterior Evaluation : E

<p>a : Cut, Fray d : Loose, Deformed k : Animal Hair s : Smell t : Cigarette Burns x : Defective y : Stain</p>

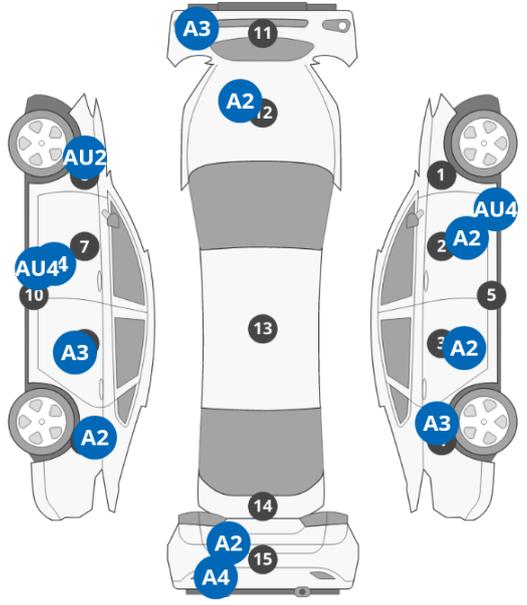
<p>A : Scratch AU : Scratch & Dent B : Modified C : Corrosion G : Stone chip P : Faded S : Rust SC : Rust & Corrosion U : Dent X : Defective Y : Crack, Gap</p>
<p>Remarks (L) Front Floor Mat - Worked - Large / (R) Front Seat - Grime - Medium / Glove Box - Worn, Scratch, Cut, Crack - Medium / Rear Seat - Grime - Small</p>	<p>Remarks (L) Front Door, Molding - Scratch - Large / (L) Step, In-panel, Side Spoiler - Scratch & Dent - Large / (L) Front Fender, Molding - Scratch & Dent - Small / Bonnet, Headlight - Scratch - Small / Front Bumper, Grille, Lamps - Scratch - Medium / (R) Front Door, Molding - Scratch - Small / (R) Step, In-panel, Side Spoiler - Scratch & Dent - Large / (R) Rear Fender, Molding - Scratch - Medium / (R) Rear Door, Molding - Scratch - Small / Rear Bumper, Lamps, Panels - Scratch - Large / Trunk Hood, Rear Gate - Scratch - Small / (L) Rear Fender, Molding - Scratch - Small / (L) Rear Door, Molding - Scratch - Medium</p>

<p>Inspector Notes</p>
<p>with warranty booklet and LTO plate, Jack, Spare tire and incomplete tools. crack and scratches on tail lights</p>
