General Information

Make	Toyota	Model	Vios
YOM	2024	Mileage	17,770
Registration No.	DBO7559	Chassis No.	PA1B18F30R4257269
CC	1.3	Transmission	CVT
Fuel Type	Gas	Type of Body	Sedan
Colour	Blue

Body / Panel Condition

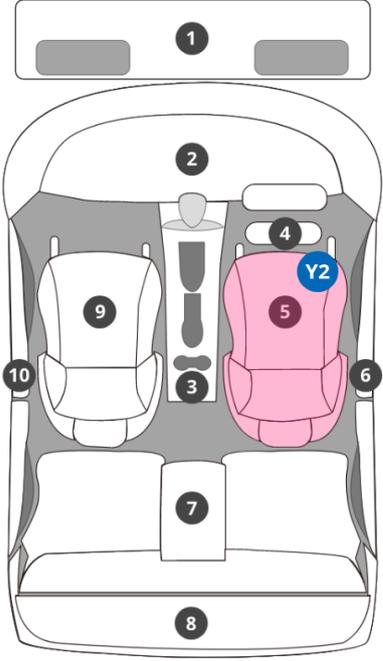
<p>a : Cut, Fray d : Loose, Deformed k : Animal Hair s : Smell t : Cigarette Burns x : Defective y : Stain</p>

<p>A : Scratch AU : Scratch & Dent B : Modified C : Corrosion G : Stone chip P : Faded S : Rust SC : Rust & Corrosion U : Dent X : Defective Y : Crack, Gap</p>
Remarks (R) Front Seat - Grime - Small	Remarks (R) Front Fender, Molding - Scratch - Minimal / (R) Front Door, Molding - Scratch - Minimal / (R) Rear Door, Molding - Scratch - Small / Trunk Hood, Rear Gate - Scratch - Small / Rear Bumper, Lamps, Panels - Scratch - Small / (R) Rear Fender, Molding - Scratch - Minimal / (L) Rear Fender, Molding - Scratch - Minimal / (L) Rear Door, Molding - Scratch - Minimal / (L) Mirror - Scratch - Minimal / (L) Front Door, Molding - Scratch - Minimal / Front Bumper, Grille, Lamps - Scratch - Small
Frame Evaluation : A	Functional Evaluation : B
