General Information

Make	Toyota	Model	Vios
YOM	2024	Mileage	14,137
Registration No.	NKI9442	Chassis No.	PA1B18F39R4260185
CC	1.3	Transmission	CVT
Fuel Type	Gas	Type of Body	Sedan
Colour	Red Mica Metallic

Body / Panel Condition

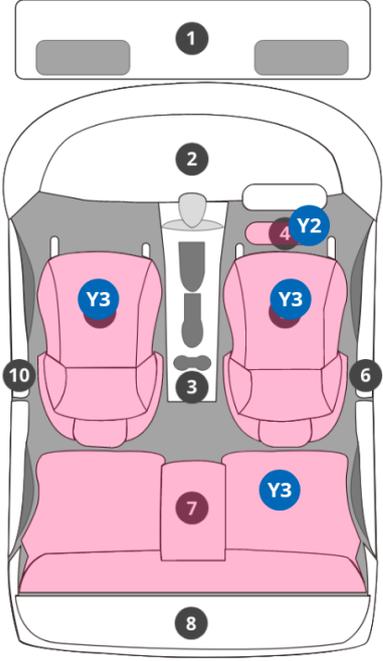
Interior Evaluation : B	Exterior Evaluation : C

<p>a : Cut, Fray d : Loose, Deformed k : Animal Hair s : Smell t : Cigarette Burns x : Defective y : Stain</p>

<p>A : Scratch AU : Scratch & Dent B : Modified C : Corrosion G : Stone chip P : Faded S : Rust SC : Rust & Corrosion U : Dent X : Defective Y : Crack, Gap</p>
<p>Remarks (R) Front Seat - Grime - Medium / (R) Front Floor Mat - Grime - Small / Rear Seat - Grime - Medium / (L) Front Seat - Grime - Medium</p>	<p>Remarks (L) Front Fender, Molding - Scratch & Dent - Minimal / (L) Front Door, Molding - Scratch & Dent - Large / (L) Step, In-panel, Side Spoiler - Scratch & Dent - Small / Trunk Hood, Rear Gate - Scratch - Medium / (R) Mirror - Scratch - Small / Bonnet, Headlight - Scratch - Medium / (L) Rear Door, Molding - Scratch - Medium / (L) Mirror - Scratch - Minimal / (R) Rear Door, Molding - Scratch & Dent - Minimal / Front Bumper, Grille, Lamps - Scratch - Small / Rear Bumper, Lamps, Panels - Scratch - Small</p>

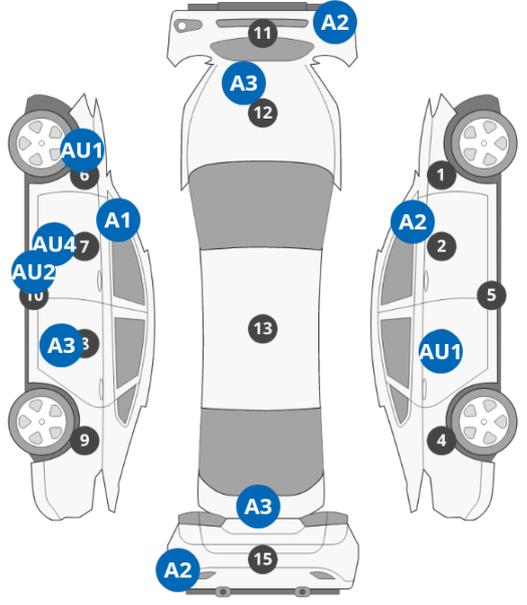
Frame Evaluation : D	Functional Evaluation : A
<p>Remarks Left Center Pillar - Traces of Bending, or Marks of Panel Repair ? - Yes</p>	<p>Remarks Spare Key - Issue - Unexist</p>
