General Information

Make	Toyota	Model	Vios
YOM	2024	Mileage	20,827
Registration No.	DBO8137	Chassis No.	PA1B18F35R4254531
CC	1.3	Transmission	CVT
Fuel Type	Gas	Type of Body	Sedan
Colour	Silver

Body / Panel Condition

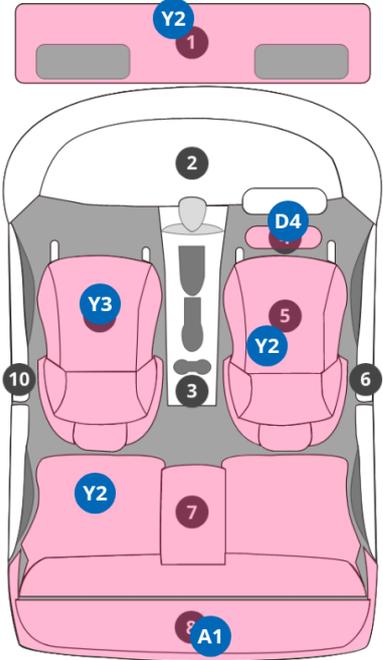
Interior Evaluation : C	Exterior Evaluation : C

<p>a : Cut, Fray d : Loose, Deformed k : Animal Hair s : Smell t : Cigarette Burns x : Defective y : Stain</p>

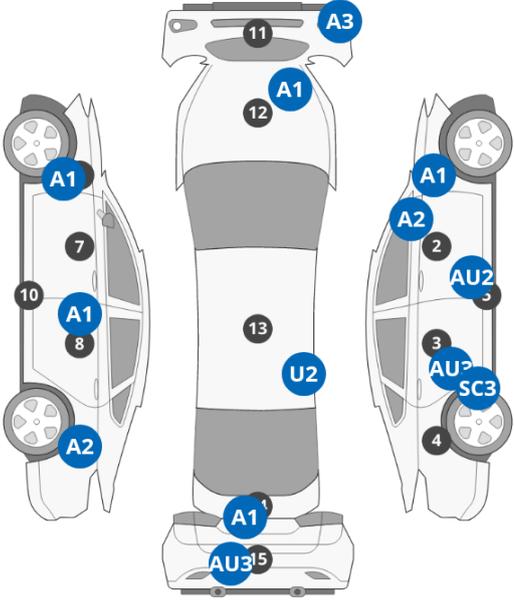
<p>A : Scratch AU : Scratch & Dent B : Modified C : Corrosion G : Stone chip P : Faded S : Rust SC : Rust & Corrosion U : Dent X : Defective Y : Crack, Gap</p>
<p>Remarks (R) Front Seat - Grime - Small / Ceiling - Grime - Small / Rear Seat - Grime - Small / (L) Front Seat - Grime - Medium / (L) Front Floor Mat - Worked - Large / Trunk Room - Worn, Scratch, Cut, Crack - Minimal</p>	<p>Remarks (R) Front Fender, Molding - Scratch - Minimal / (R) Front Door, Molding - Scratch & Dent - Small / (R) Rear Door, Molding - Scratch & Dent - Medium / (R) Rear Fender, Molding - Rust, Corrosion - Medium / Rear Bumper, Lamps, Panels - Scratch & Dent - Medium / Trunk Hood, Rear Gate - Scratch - Minimal / (L) Rear Fender, Molding - Scratch - Small / (L) Rear Door, Molding - Scratch - Minimal / (L) Front Fender, Molding - Scratch - Minimal / Front Bumper, Grille, Lamps - Scratch - Medium / Roof Spoiler, Molding - Dent - Small / Bonnet, Headlight - Scratch - Minimal / (R) Mirror - Scratch - Small</p>
