General Information

Make	Toyota	Model	Vios
YOM	2024	Mileage	14,855
Registration No.	NHS4002	Chassis No.	PA1B18F35R4259342
CC	1.3	Transmission	CVT
Fuel Type	Gas	Type of Body	Sedan
Colour	Red Mica Metallic

Body / Panel Condition

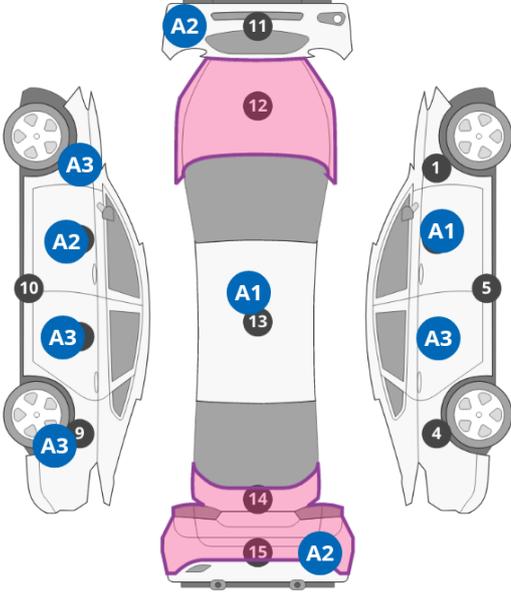
</div> <p>A : Scratch AU : Scratch & Dent B : Modified C : Corrosion G : Stone chip P : Faded S : Rust SC : Rust & Corrosion U : Dent X : Defective Y : Crack, Gap</p>
<p>Remarks (L) Front Floor Mat - Worked - Large / (R) Front Seat - Grime - Medium</p>	<p>Remarks (R) Front Fender - Repair Traces - Yes / Bonnet - Repair Traces - Yes / Trunk Hood, Rear Gate - Repair Traces - Yes / Trunk Hood, Rear Gate - Repair mark - Yes / Bonnet, Headlight - Repair mark - Yes / (L) Front Fender, Molding - Scratch - Medium / Front Bumper, Grille, Lamps - Scratch - Small / (L) Rear Fender, Molding - Scratch - Medium / (L) Front Door, Molding - Scratch - Small / (R) Front Door, Molding - Scratch - Minimal / Roof - Scratch - Minimal / Trunk Hood, Rear Gate - Scratch - Small / (L) Rear Door, Molding - Scratch - Medium / (R) Rear Door, Molding - Scratch - Medium</p>
