## General Information

| Make | Toyota | Model | Vios |

## Body / Panel Condition

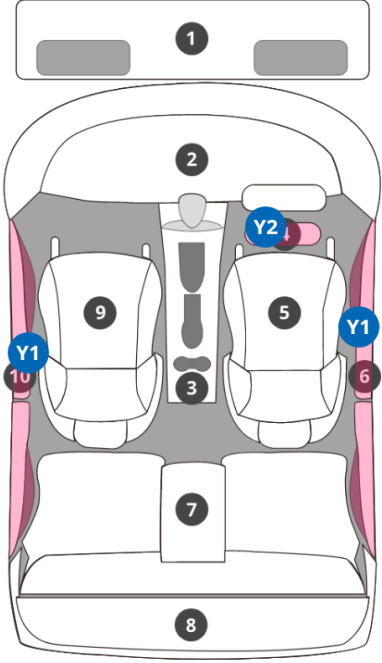
| <b>Interior Evaluation :</b> <span style="color: red; font-weight: bold;">A</span> | <b>Exterior Evaluation :</b> <span style="color: red; font-weight: bold;">B</span> |
| <b>Remarks</b><br>(R) Front Trim - Grime - Minimal / (L) Front Trim - Grime - Minimal / (L) Front Floor Mat - Grime - Small | <b>Remarks</b><br>(R) Front Fender, Molding - Scratch - Minimal / (R) Mirror - Scratch - Minimal / (R) Rear Fender, Molding - Scratch - Minimal / Rear Bumper, Lamps, Panels - Scratch - Small / Trunk Hood, Rear Gate - Scratch - Minimal / (L) Rear Door, Molding - Scratch - Minimal / (L) Front Fender, Molding - Scratch - Minimal / Front Bumper, Grille, Lamps - Scratch - Medium |
