## General Information

| Make | Toyota | Model | Vios |
| YOM | 2024 | Mileage | 30,031 |
| Registration No. | VAB9239 | Chassis No. | PA1B18F30P4237164 |

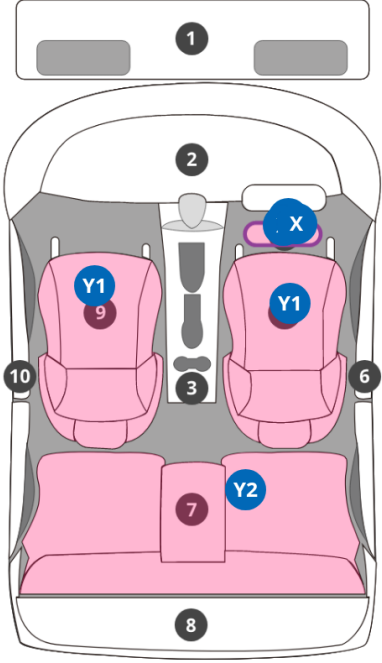
| <b>Remarks</b><br>(L) Front Floor Mat - Missing - Yes / (R) Front Floor Mat - Missing - Yes / Mat Other - Missing - Yes / (L) Front Seat - Grime - Minimal / Rear Seat - Grime - Small / (R) Front Seat - Grime - Minimal | <b>Remarks</b><br>(R) Rear Fender, Molding - Scratch & Dent - Small / (R) Front Fender, Molding - Scratch - Small / Front Bumper, Grille, Lamps - Scratch - Minimal / (L) Front Fender, Molding - Scratch - Minimal / Trunk Hood, Rear Gate - Scratch - Minimal / (R) Front Door, Molding - Scratch - Medium |
