## General Information

| Make | Toyota | Model | Vios |
| YOM | 2024 | Mileage | 23,640 |
| Registration No. | CCA9361 | Chassis No. | PA1B18F32R4260402 |

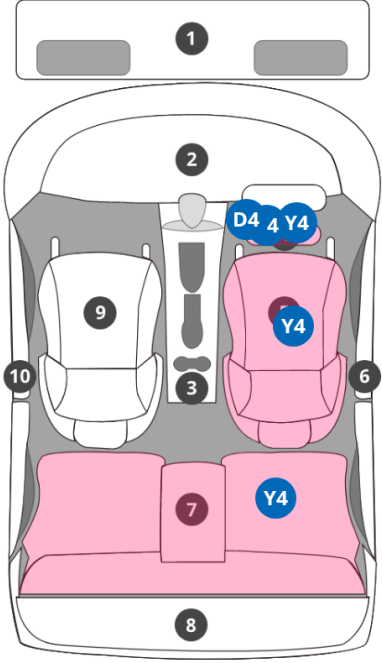
| <b>Interior Evaluation :</b> <span style="color: red; font-weight: bold;">C</span> | <b>Exterior Evaluation :</b> <span style="color: red; font-weight: bold;">D</span> |
| <b>Remarks</b><br>Rear Seat - Grime - Large / Mat Other - Grime - Large / (R) Front Seat - Grime - Large / (R) Front Floor Mat - Grime - Large / (L) Front Floor Mat - Worked - Large | <b>Remarks</b><br>(R) Front Fender - Repair Traces - Yes / Bonnet - Repair Traces - Yes / Member (Bolted) - Dent - Yes / Front Bumper, Grille, Lamps - Repair mark - Yes / Front Bumper, Grille, Lamps - Crack, Gap - Large / (L) Step, In-panel, Side Spoiler - Scratch - Medium / (L) Front Door, Molding - Scratch - Small / (L) Rear Door, Molding - Scratch - Small / Trunk Hood, Rear Gate - Dent - Small / Rear Bumper, Lamps, Panels - Scratch - Medium / (R) Rear Fender, Molding - Scratch & Dent - Large / (R) Rear Door, Molding - Scratch - Small / (R) Front Door, Molding - Scratch - Small / (R) Front Fender, Molding - Scratch - Small / Bonnet, Headlight - Crack, Gap - Small |
