## General Information

| Make | Suzuki | Model | Dzire |

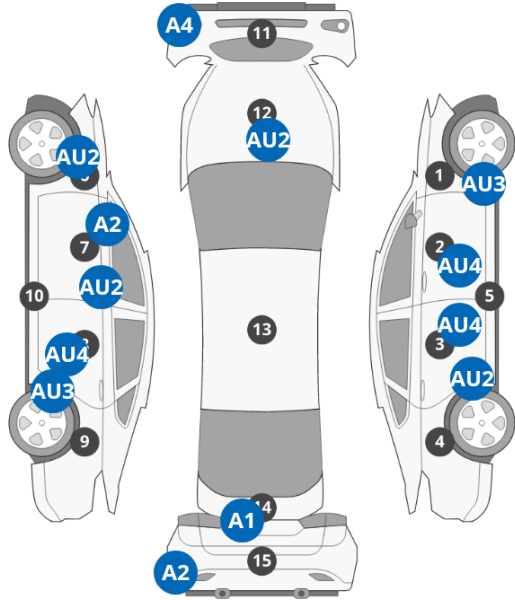
| Interior Evaluation : <span style="color: red;">A</span> | Exterior Evaluation : <span style="color: red;">E</span> |
|---|---|
| <b>Remarks</b><br>Dashboard - Traces of Adhesive Tape - Yes / Console, Switches, Vents - Traces of Adhesive Tape - Yes / (L) Front Seat - Grime - Minimal | <b>Remarks</b><br>Trunk Hood, Rear Gate - Repair Traces - Yes / (R) Front Fender, Molding - Scratch & Dent - Medium / (R) Front Door, Molding - Scratch & Dent - Large / (R) Rear Door, Molding - Scratch & Dent - Large / (R) Rear Fender, Molding - Scratch & Dent - Small / Rear Bumper, Lamps, Panels - Scratch - Small / Trunk Hood, Rear Gate - Scratch - Minimal / (L) Rear Fender, Molding - Scratch & Dent - Medium / (L) Rear Door, Molding - Scratch & Dent - Large / (L) Mirror - Scratch - Small / (L) Front Door, Molding - Scratch & Dent - Small / (L) Front Fender, Molding - Scratch & Dent - Small / Front Bumper, Grille, Lamps - Scratch - Large / Bonnet, Headlight - Scratch & Dent - Small |

with warranty booklet, no jack, no tools, with spare tire, with LTO plate, crack and scratches on tail light, signal light issue
