## General Information

| Make | Toyota | Model | Vios |
| YOM | 2024 | Mileage | 8,165 |
| Registration No. | BAG6611 | Chassis No. | PA1B18F30R4276386 |

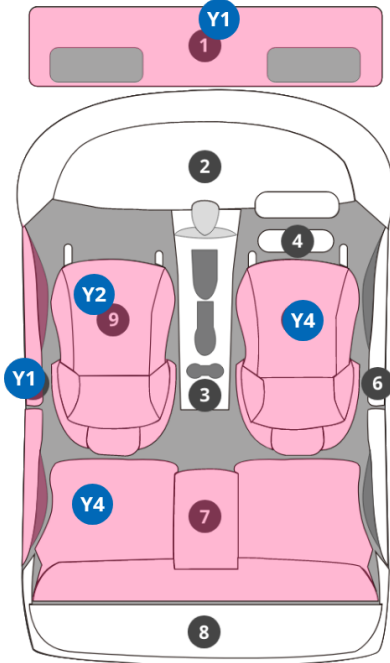
| Interior Evaluation : <span style="color: red;">C</span> | Exterior Evaluation : <span style="color: red;">E</span> |
|---|---|
| <p><b>Remarks</b><br/>Rear Seat - Grime - Large / (L) Front Trim - Grime - Minimal / (L) Front Seat - Grime - Small / Ceiling - Grime - Minimal / (R) Front Seat - Grime - Large</p> | <p><b>Remarks</b><br/>(R) Front Fender, Molding - Scratch - Small / (R) Front Door, Molding - Scratch &amp; Dent - Small / (R) Rear Door, Molding - Scratch &amp; Dent - Medium / (R) Step, In-panel, Side Spoiler - Scratch &amp; Dent - Large / (R) Rear Fender, Molding - Scratch - Minimal / Trunk Hood, Rear Gate - Scratch - Minimal / Rear Bumper, Lamps, Panels - Scratch - Small / (L) Rear Fender, Molding - Scratch &amp; Dent - Medium / (L) Rear Door, Molding - Scratch &amp; Dent - Large / (L) Front Door, Molding - Scratch - Large / (L) Front Fender, Molding - Scratch - Small / Front Bumper, Grille, Lamps - Scratch &amp; Dent - Medium / Bonnet, Headlight - Scratch - Minimal</p> |
