## General Information

| Make | Toyota | Model | Vios |

## Body / Panel Condition

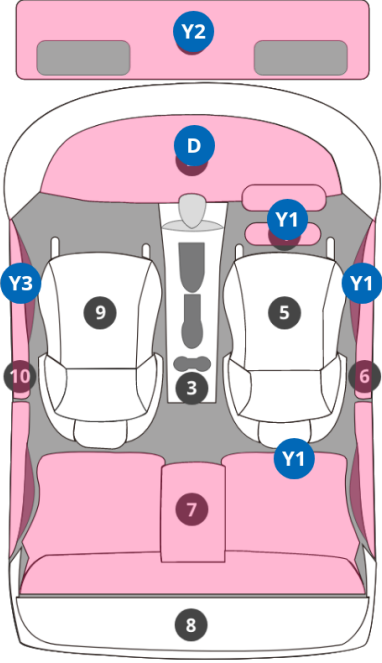
| Interior Evaluation : <b>B</b> | Exterior Evaluation : <b>A</b> |
|---|---|
| <p><b>Remarks</b></p> <p>(R) Front Trim - Grime - Minimal / Dashboard - Traces of Adhesive Tape - Yes / Rear Seat - Grime - Minimal / (L) Front Floor Mat - Grime - Minimal / (L) Front Trim - Grime - Medium / Ceiling - Grime - Small</p> | <p><b>Remarks</b></p> <p>Trunk Hood, Rear Gate - Scratch - Minimal / Rear Bumper, Lamps, Panels - Scratch - Minimal / (L) Rear Fender, Molding - Scratch - Small / (L) Front Door, Molding - Scratch - Minimal / (R) Front Door, Molding - Scratch - Small / (R) Rear Fender, Molding - Scratch - Minimal</p> |
