## General Information

| Make | Toyota | Model | Vios |

## Body / Panel Condition

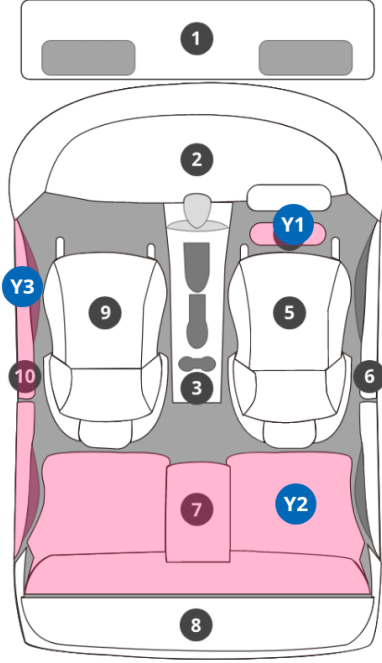
| <p><b>a</b> : Cut, Fray <b>d</b> : Loose, Deformed <b>k</b> : Animal Hair <b>s</b> : Smell <b>t</b> : Cigarette Burns <b>x</b> : Defective <b>y</b> : Stain</p> | <p><b>A</b> : Scratch <b>AU</b> : Scratch &amp; Dent <b>B</b> : Modified <b>C</b> : Corrosion <b>G</b> : Stone chip <b>P</b> : Faded <b>S</b> : Rust <b>SC</b> : Rust &amp; Corrosion <b>U</b> : Dent <b>X</b> : Defective <b>Y</b> : Crack, Gap</p> |
| <b>Remarks</b><br>Rear Seat - Grime - Small / (L) Front Floor Mat - Grime - Minimal / (L) Front Trim - Grime - Medium | <b>Remarks</b><br>Trunk Hood, Rear Gate - Scratch & Dent - Medium / Rear Bumper, Lamps, Panels - Scratch - Large / (R) Rear Fender, Molding - Scratch - Small / (R) Front Door, Molding - Scratch - Minimal / (R) Rear Door, Molding - Scratch - Small / Front Bumper, Grille, Lamps - Scratch - Small / (L) Front Door, Molding - Scratch - Minimal / (L) Rear Door, Molding - Scratch - Small / (L) Rear Fender, Molding - Scratch - Minimal / Bonnet, Headlight - Scratch - Minimal |
