## General Information

| Make | Toyota | Model | Innova |

## Body / Panel Condition

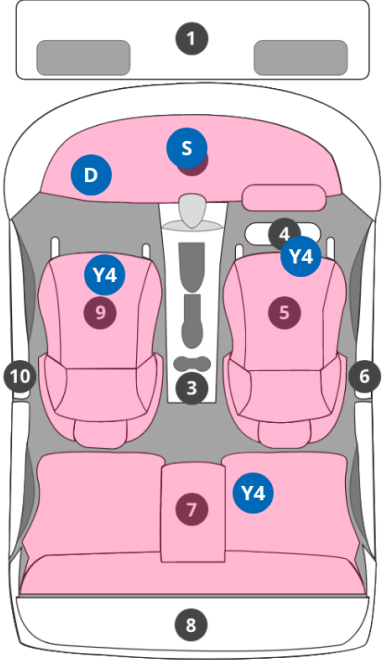
| Interior Evaluation : <span style="color: red;">C</span> | Exterior Evaluation : <span style="color: red;">E</span> |
| <p><b>Remarks</b><br/>(L) Front Seat - Grime - Large / (R) Front Seat - Grime - Large / Rear Seat - Grime - Large / Overall Interior - Smell - Yes / Dashboard - Traces of Adhesive Tape - Yes</p> | <p><b>Remarks</b><br/>Trunk Hood, Rear Gate - Scratch &amp; Dent - Large / Rear Bumper, Lamps, Panels - Scratch &amp; Dent - Large / (L) Step, In-panel, Side Spoiler - Scratch &amp; Dent - Large / (L) Rear Door, Molding - Scratch &amp; Dent - Large / (L) Front Door, Molding - Scratch &amp; Dent - Large / Front Bumper, Grille, Lamps - Scratch - Large / Bonnet, Headlight - Dent - Medium / (R) Front Door, Molding - Scratch &amp; Dent - Small / (R) Rear Door, Molding - Scratch - Medium</p> |
