## General Information

| Make | Toyota | Model | Vios |
| Registration No. | CCA9081 | Chassis No. | PA1B18F30R4258437 |

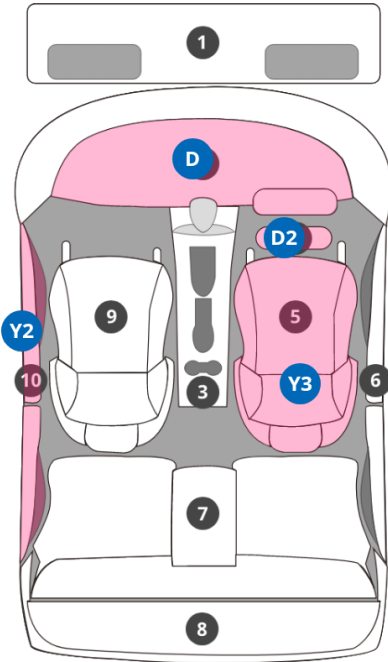
| Interior Evaluation : <span style="color: red; font-weight: bold;">B</span> | | Exterior Evaluation : <span style="color: red; font-weight: bold;">B</span> | |
| <p><b>Remarks</b></p> <p>(R) Front Seat - Grime - Medium / (L) Front Floor Mat - Worked - Small / (L) Front Trim - Grime - Small / Dashboard - Traces of Adhesive Tape - Yes</p> | | <p><b>Remarks</b></p> <p>Roof - Repair Traces - Yes / (R) Front Door, Molding - Scratch - Small / (R) Rear Door, Molding - Scratch - Minimal / (R) Rear Fender, Molding - Scratch - Small / Rear Bumper, Lamps, Panels - Scratch - Small / Trunk Hood, Rear Gate - Scratch - Small / (L) Rear Fender, Molding - Scratch - Minimal / (L) Rear Door, Molding - Scratch - Small / (L) Front Door, Molding - Scratch - Small / (L) Mirror - Scratch - Minimal / Member (Bolted) - Dent - Yes / Front Bumper, Grille, Lamps - Scratch - Small / Bonnet, Headlight - Scratch - Small</p> | |
