## General Information

| Make | Toyota | Model | Vios |
| YOM | 2025 | Mileage | 5,235 |

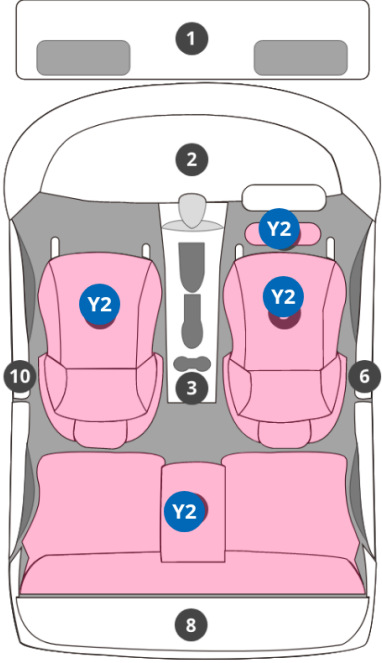
| <b>Interior Evaluation :</b> <span style="color: red; font-weight: bold;">A</span> | <b>Exterior Evaluation :</b> <span style="color: red; font-weight: bold;">D</span> |
| <b>Remarks</b><br>(L) Front Floor Mat - Grime - Small / (L) Front Seat - Grime - Small / (R) Front Seat - Grime - Small / Rear Seat - Grime - Small | <b>Remarks</b><br>(R) Front Door - Repair Traces - Yes / Front Bumper, Grille, Lamps - Scratch & Dent - Large / (R) Front Fender, Molding - Scratch & Dent - Large / (L) Front Fender, Molding - Scratch - Minimal / (L) Mirror - Scratch - Minimal / (L) Rear Door, Molding - Scratch & Dent - Medium / (L) Step, In-panel, Side Spoiler - Scratch & Dent - Medium / Trunk Hood, Rear Gate - Scratch - Minimal / (R) Rear Door, Molding - Scratch - Medium / (R) Front Door, Molding - Scratch - Medium / Roof - Scratch - Minimal / (R) Rear Fender, Molding - Scratch - Minimal / (L) Rear Fender, Molding - Scratch - Minimal |
