## General Information

| Make | Toyota | Model | Vios |
| YOM | 2024 | Mileage | 10,806 |
| Registration No. | DBM2182 | Chassis No. | PA1B18F3XP4237964 |

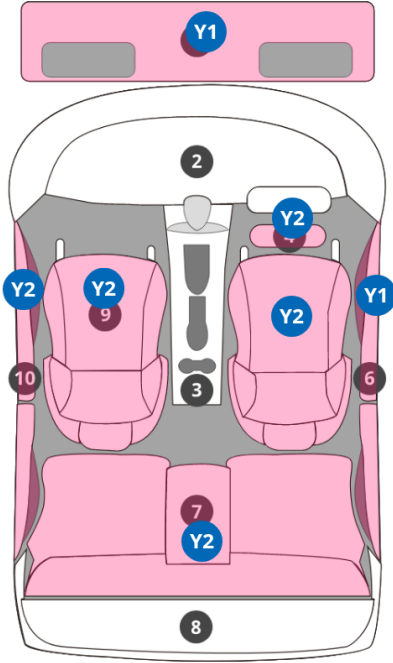
| Interior Evaluation : <b>B</b> | Exterior Evaluation : <b>C</b> |
|---|---|
| <p><b>Remarks</b><br/>(L) Front Floor Mat - Grime - Small / (L) Front Trim - Grime - Small / (R) Front Trim - Grime - Minimal / (R) Front Seat - Grime - Small / Rear Seat - Grime - Small / (L) Front Seat - Grime - Small / Ceiling - Grime - Minimal</p> | <p><b>Remarks</b><br/>Rear Bumper, Lamps, Panels - Scratch - Medium / (R) Rear Fender, Molding - Scratch - Minimal / (R) Rear Door, Molding - Scratch - Medium / (R) Front Door, Molding - Scratch - Medium / (R) Mirror - Scratch - Minimal / Front Bumper, Grille, Lamps - Scratch - Medium / Bonnet, Headlight - Scratch - Minimal / (L) Front Fender, Molding - Scratch &amp; Dent - Medium / (L) Rear Door, Molding - Scratch - Medium / (L) Front Door, Molding - Dent - Small / (L) Rear Fender, Molding - Scratch - Small</p> |
