## General Information

| Make | Hyundai | Model | Starex |
| YOM | 2019 | Odo Meter Reading | 49,542 |
| Registration No. | NBH8887 | Chassis No. | KMJWA37KBKU024086 |

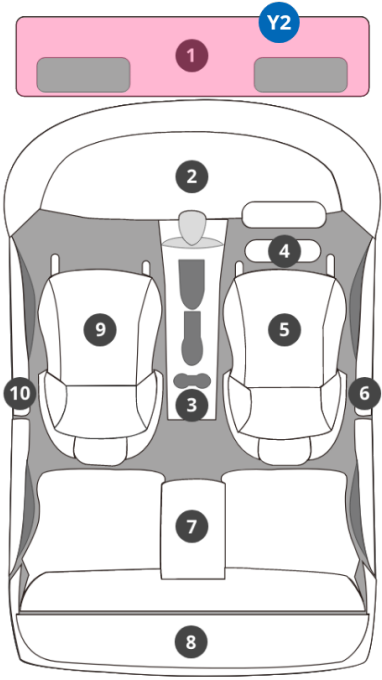
| <b>Interior Evaluation :</b> <span style="color: red; font-weight: bold;">C</span> | <b>Exterior Evaluation :</b> <span style="color: red; font-weight: bold;">C</span> |
| <b>Remarks</b><br>Overall Interior - Worn as per age - Yes / Ceiling - Grime - Small | <b>Remarks</b><br>(R) Rear Fender, Molding - Scratch - Small / (R) Rear Door, Molding - Scratch - Small / (R) Front Door, Molding - Scratch - Small / (R) Mirror - Scratch - Minimal / Front Bumper, Grille, Lamps - Scratch - Small / (L) Front Door, Molding - Scratch - Small / (L) Rear Door, Molding - Scratch - Small / (L) Rear Fender, Molding - Scratch - Small / Rear Bumper, Lamps, Panels - Scratch - Small / Trunk Hood, Rear Gate - Scratch - Small / Roof - Scratch - Small / Bonnet, Headlight - Scratch - Small |
