## General Information

| Make | Toyota | Model | Vios |

## Body / Panel Condition

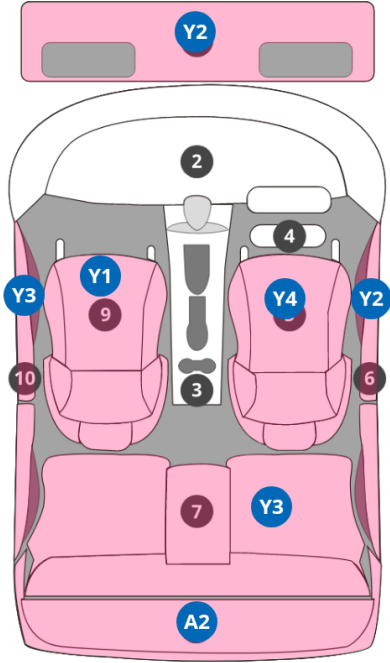
| Interior Evaluation : <b>C</b> | Exterior Evaluation : <b>C</b> |
| <p><b>Remarks</b><br/>(L) Front Seat - Grime - Minimal / (L) Front Trim - Grime - Medium / (R) Front Seat - Grime - Large / Rear Seat - Grime - Medium / (R) Front Trim - Grime - Small / Trunk Room - Worn, Scratch, Cut, Crack - Small / Ceiling - Grime - Small</p> | <p><b>Remarks</b><br/>(L) Rear Fender, Molding - Scratch - Minimal / (L) Rear Door, Molding - Scratch - Minimal / (L) Front Fender, Molding - Scratch - Minimal / Front Bumper, Grille, Lamps - Scratch &amp; Dent - Large / (R) Front Fender, Molding - Scratch - Small / (R) Front Door, Molding - Scratch - Small / (R) Rear Door, Molding - Scratch - Small / (R) Rear Fender, Molding - Scratch &amp; Dent - Small / Roof - Scratch - Small / Rear Bumper, Lamps, Panels - Scratch - Small / (L) Front Door, Molding - Scratch - Minimal / (R) Step, In-panel, Side Spoiler - Scratch - Minimal / Bonnet, Headlight - Scratch - Minimal</p> |

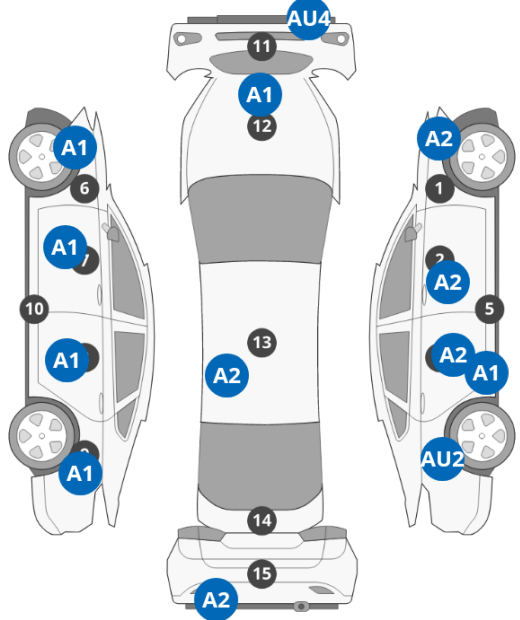
| Inspector Notes |
|---|
| with LTO plate/with spare tire/with warranty booklets/with jack and tools/No reverse camera/rear bumper re-painted |
