## General Information

| Make | Toyota | Model | Vios |
| YOM | 2024 | Mileage | 11,580 |
| Registration No. | DBO8993 | Chassis No. | PA1B18F34R4254018 |

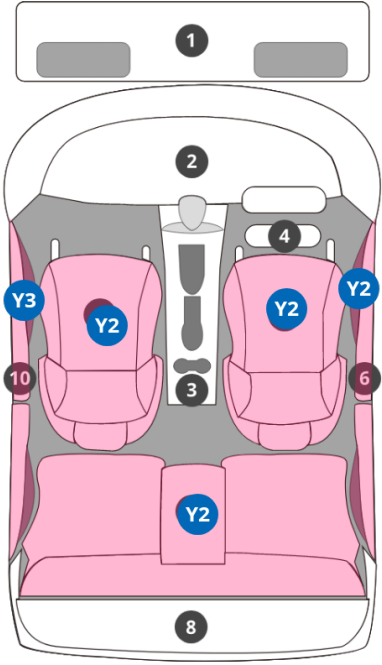
| Interior Evaluation : <b>B</b> | Exterior Evaluation : <b>E</b> |
| <b>Remarks</b><br>(L) Front Trim - Grime - Medium / (R) Front Seat - Grime - Small / (L) Front Seat - Grime - Small / Rear Seat - Grime - Small / (R) Front Trim - Grime - Small | <b>Remarks</b><br>Rear Bumper, Lamps, Panels - Scratch - Small / (R) Rear Fender, Molding - Scratch - Medium / (R) Rear Door, Molding - Scratch & Dent - Large / (R) Front Door, Molding - Scratch & Dent - Large / (R) Step, In-panel, Side Spoiler - Scratch & Dent - Large / (R) Front Fender, Molding - Scratch & Dent - Medium / (R) Mirror - Scratch - Minimal / Front Bumper, Grille, Lamps - Scratch - Medium / Bonnet, Headlight - Scratch & Dent - Small / (L) Front Fender, Molding - Scratch - Small / (L) Front Door, Molding - Scratch - Minimal / (L) Mirror - Scratch - Minimal / (L) Rear Door, Molding - Scratch - Small / Trunk Hood, Rear Gate - Scratch - Minimal / (L) Rear Fender, Molding - Scratch - Minimal |
