## General Information

| Make | Toyota | Model | Vios |

## Body / Panel Condition

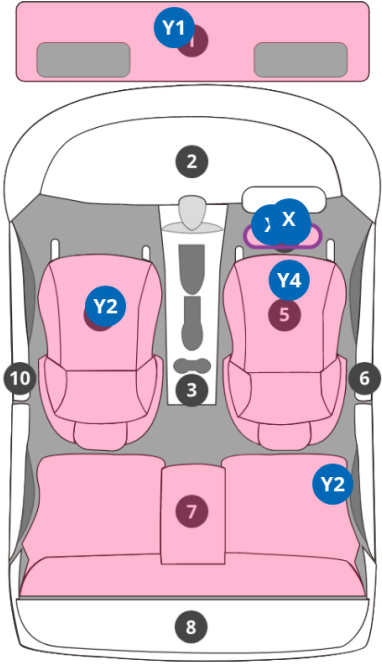
| Interior Evaluation : <span style="color: red;">C</span> | Exterior Evaluation : <span style="color: red;">C</span> |
| <b>Remarks</b><br>(R) Front Seat - Grime - Large / (R) Front Floor Mat - Missing - Yes / (L) Front Floor Mat - Missing - Yes / Mat Other - Missing - Yes / Rear Seat - Grime - Small / (L) Front Seat - Grime - Small / Ceiling - Grime - Minimal | <b>Remarks</b><br>Member (Bolted) - Dent - Yes / (R) Front Fender, Molding - Scratch - Minimal / (R) Mirror - Scratch - Minimal / (R) Front Door, Molding - Scratch - Minimal / (R) Rear Door, Molding - Scratch & Dent - Medium / Rear Bumper, Lamps, Panels - Scratch & Dent - Large / (L) Rear Fender, Molding - Scratch - Minimal / (L) Rear Door, Molding - Scratch - Minimal / (L) Front Door, Molding - Scratch - Minimal / (L) Mirror - Scratch - Minimal / Front Bumper, Grille, Lamps - Scratch - Medium / (R) Rear Fender, Molding - Scratch - Minimal / (L) Front Fender, Molding - Scratch - Minimal |
