## General Information

| Make | Toyota | Model | Vios |
| Registration No. | EAG6499 | Chassis No. | PA1B18F32P4237618 |

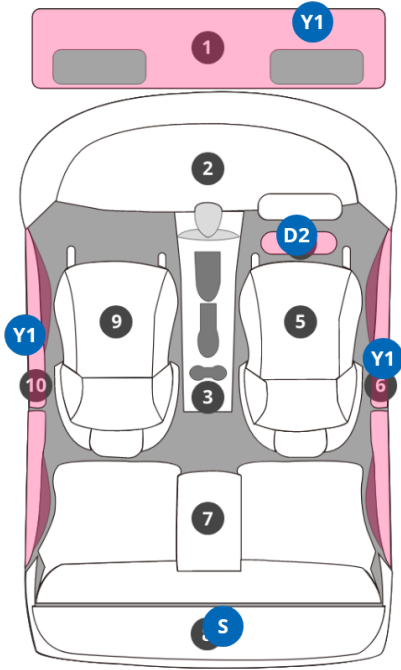
| Interior Evaluation : <b>B</b> | Exterior Evaluation : <b>E</b> |
|---|---|
| <p><b>Remarks</b><br/>(L) Front Floor Mat - Worked - Small / Ceiling - Grime - Minimal / (R) Front Trim - Grime - Minimal / (L) Front Trim - Grime - Minimal / Overall Interior - Smell - Yes</p> | <p><b>Remarks</b><br/>(R) Front Fender, Molding - Scratch &amp; Dent - Large / (R) Mirror - Scratch - Small / (R) Front Door, Molding - Scratch &amp; Dent - Small / (R) Rear Door, Molding - Scratch - Small / (R) Rear Fender, Molding - Scratch - Small / Rear Bumper, Lamps, Panels - Scratch &amp; Dent - Medium / Trunk Hood, Rear Gate - Scratch &amp; Dent - Medium / (L) Rear Fender, Molding - Scratch - Large / (L) Rear Door, Molding - Scratch - Large / (L) Front Door, Molding - Scratch - Large / (L) Mirror - Scratch - Small / (L) Front Fender, Molding - Scratch &amp; Dent - Large / Member (Bolted) - Dent - Yes / Front Bumper, Grille, Lamps - Modified - Small / Front Bumper, Grille, Lamps - Scratch &amp; Dent - Large / Bonnet, Headlight - Dent - Large / Roof - Scratch - Minimal / (R) Rear Wheel, Cover - Cap Missing - Yes</p> |
