## General Information

| Make | Toyota | Model | Innova |

## Body / Panel Condition

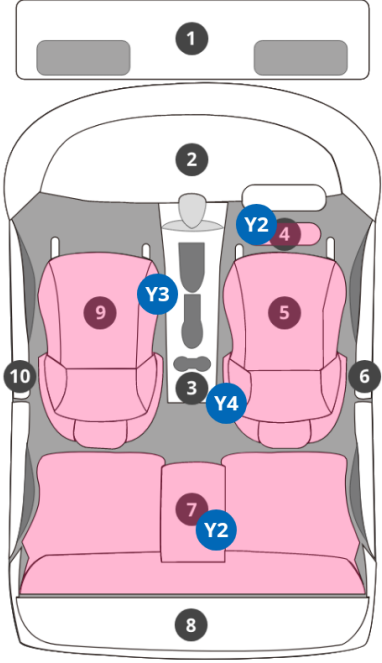
| Interior Evaluation : <span style="color: red;">C</span> | Exterior Evaluation : <span style="color: red;">E</span> |
| <b>Remarks</b><br>(R) Front Seat - Grime - Large / Rear Seat - Grime - Small / (L) Front Seat - Grime - Medium / (L) Front Floor Mat - Grime - Small | <b>Remarks</b><br>Front Bumper, Grille, Lamps - Scratch & Dent - Large / (L) Front Fender, Molding - Scratch & Dent - Small / (L) Front Door, Molding - Scratch - Large / (L) Rear Door, Molding - Scratch & Dent - Large / (L) Rear Fender, Molding - Scratch - Large / Trunk Hood, Rear Gate - Scratch & Dent - Medium / Rear Bumper, Lamps, Panels - Scratch - Large / (R) Rear Fender, Molding - Scratch & Dent - Large / (L) Step, In-panel, Side Spoiler - Scratch & Dent - Small / (R) Rear Door, Molding - Scratch - Large / (R) Front Door, Molding - Scratch & Dent - Large / (R) Front Fender, Molding - Scratch & Dent - Medium / Roof - Dent - Small / (L) Front Wheel, Cover - Cap Missing - Yes / (R) Rear Wheel, Cover - Cap Missing - Yes |
