## General Information

| Make | Toyota | Model | Vios |
| Registration No. | NFR7749 | Chassis No. | PA1B18F30R4255957 |

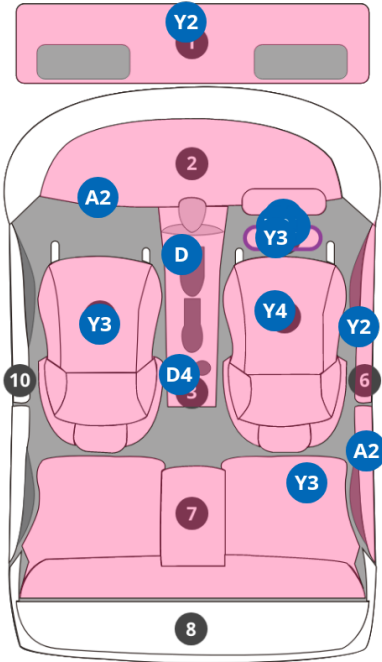
| Interior Evaluation : <b>E</b> | Exterior Evaluation : <b>E</b> |
| <p><b>Remarks</b></p> <p>(R) Front Seat - Grime - Large / (L) Front Seat - Grime - Medium / Ceiling - Grime - Small / Rear Seat - Grime - Medium / Mat Other - Grime - Medium / (R) Rear Trim - Cut, Crack - Small / (R) Front Trim - Grime - Small / (R) Front Floor Mat - Missing - Yes / (L) Front Floor Mat - Worked - Small / (L) Front Floor Mat - Grime - Medium / Console, Switchs, Vents - Traces of Adhesive Tape - Yes / Steering Wheel - Worn, Peel, Crack - Small / Console, Switchs, Vents - Loose, Deformed - Large</p> | <p><b>Remarks</b></p> <p>Rear Windshield - Damaged - Large / (R) Front Fender, Molding - Scratch &amp; Dent - Large / (R) Mirror - Scratch - Small / (R) Front Door, Molding - Scratch &amp; Dent - Medium / (R) Rear Door, Molding - Scratch &amp; Dent - Large / (R) Step, In-panel, Side Spoiler - Scratch &amp; Dent - Large / (R) Rear Fender, Molding - Scratch &amp; Dent - Medium / Rear Bumper, Lamps, Panels - Scratch - Large / Trunk Hood, Rear Gate - Scratch - Small / (L) Rear Fender, Molding - Scratch - Small / (L) Rear Door, Molding - Scratch - Medium / (L) Step, In-panel, Side Spoiler - Scratch &amp; Dent - Large / (L) Front Door, Molding - Scratch - Medium / (L) Mirror - Scratch - Small / Front Bumper, Grille, Lamps - Scratch &amp; Dent - Large / Bonnet, Headlight - Scratch &amp; Dent - Large</p> |

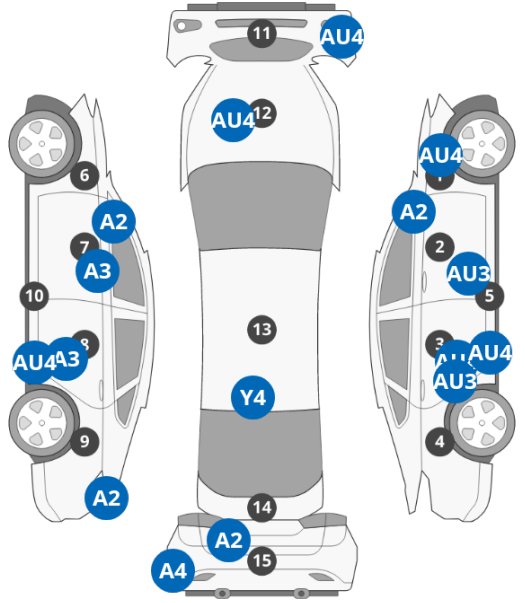
| Inspector Notes |
|---|
| <p>with warranty booklet, with jack, incomplete tools, with spare tire, with LTO plate (under passenger seat), scratches on tail light and head light, possible flooding</p> |
