## General Information

| Make | Toyota | Model | Vios |

## Body / Panel Condition

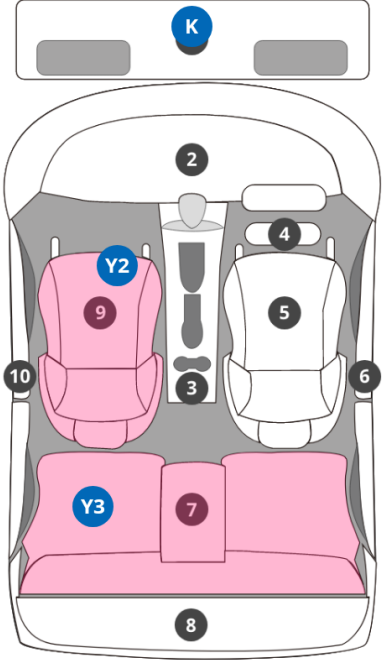
| <b>Interior Evaluation :</b> <span style="color: red; font-weight: bold;">B</span> | <b>Exterior Evaluation :</b> <span style="color: red; font-weight: bold;">C</span> |
| <b>Remarks</b><br>Rear Seat - Grime - Medium / (L) Front Seat - Grime - Small / Overall Interior - Animal Hair - Yes | <b>Remarks</b><br>(R) Rear Door, Molding - Scratch & Dent - Small / (L) Step, In-panel, Side Spoiler - Scratch & Dent - Medium / (L) Mirror - Scratch - Medium / (L) Rear Door, Molding - Scratch - Large / Roof - Dent - Minimal / (L) Front Door, Molding - Scratch - Small / Front Bumper, Grille, Lamps - Scratch - Large / (R) Mirror - Scratch - Minimal / (R) Front Door, Molding - Dent - Minimal / Rear Bumper, Lamps, Panels - Scratch - Small |
