## General Information

| Make | Toyota | Model | Vios |

## Body / Panel Condition

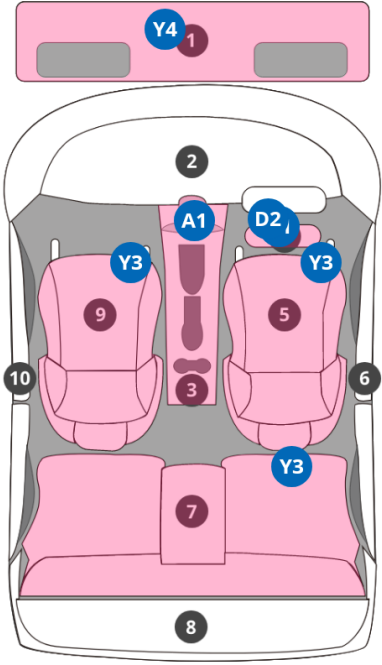
| Interior Evaluation : <span style="color: red;">C</span> | Exterior Evaluation : <span style="color: red;">D</span> |
| <b>Remarks</b><br>(R) Front Seat - Grime - Medium / (L) Front Seat - Grime - Medium / Rear Seat - Grime - Medium / (L) Front Floor Mat - Cut, Crack - Minimal / (L) Front Floor Mat - Worked - Small / Console, Switches, Vents - Worn, Scratch, Cut, Crack - Minimal / Ceiling - Grime - Large | <b>Remarks</b><br>(R) Mirror - Scratch - Small / (R) Front Fender, Molding - Scratch - Small / (R) Front Door, Molding - Scratch - Medium / (R) Rear Door, Molding - Scratch - Small / (R) Rear Fender, Molding - Scratch - Minimal / Trunk Hood, Rear Gate - Scratch - Small / Rear Bumper, Lamps, Panels - Scratch - Large / (L) Rear Fender, Molding - Scratch - Small / (L) Mirror - Scratch - Small / (L) Front Door, Molding - Scratch - Small / (L) Rear Door, Molding - Scratch - Small / Member (Bolted) - Dent - Yes / Front Bumper, Grille, Lamps - Scratch - Large / Bonnet, Headlight - Scratch - Minimal |
