## General Information

| Make | Toyota | Model | Vios |
| YOM | 2024 | Mileage | 9,295 |

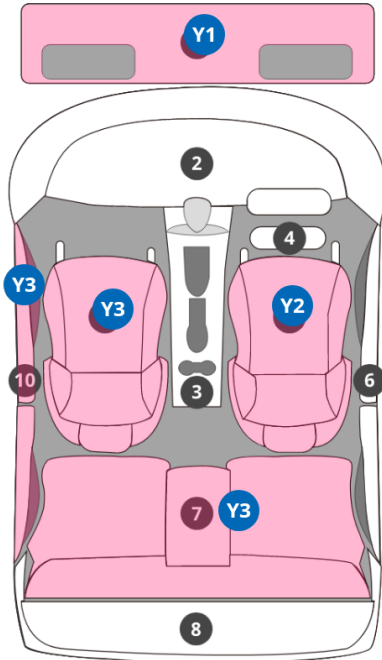
| <b>Interior Evaluation :</b> <b>B</b> | <b>Exterior Evaluation :</b> <b>C</b> |
| <b>Remarks</b><br>(L) Front Seat - Grime - Medium / (L) Front Trim - Grime - Medium / Rear Seat - Grime - Medium / (R) Front Seat - Grime - Small / Ceiling - Grime - Minimal | <b>Remarks</b><br>(R) Rear Fender, Molding - Scratch - Minimal / Rear Bumper, Lamps, Panels - Scratch - Medium / Trunk Hood, Rear Gate - Scratch - Minimal / (L) Rear Door, Molding - Scratch - Small / Front Bumper, Grille, Lamps - Scratch - Medium / Bonnet, Headlight - Scratch - Small / (R) Front Door, Molding - Scratch - Small / (R) Front Fender, Molding - Scratch - Minimal / (R) Rear Door, Molding - Scratch - Small / (L) Rear Fender, Molding - Scratch - Minimal / (L) Front Fender, Molding - Scratch - Minimal |
