## General Information

| Make | Toyota | Model | Vios |

## Body / Panel Condition

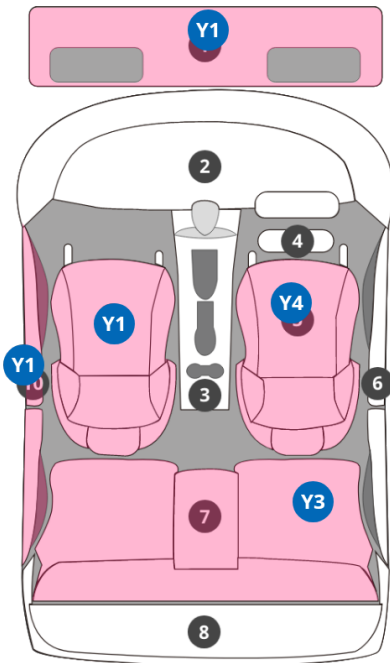
| <b>Remarks</b><br>(R) Front Seat - Grime - Large / (L) Front Trim - Grime - Minimal / Rear Seat - Grime - Medium / Ceiling - Grime - Minimal / (L) Front Seat - Grime - Minimal | <b>Remarks</b><br>(R) Front Fender, Molding - Scratch - Minimal / (R) Front Door, Molding - Scratch - Minimal / (R) Rear Door, Molding - Scratch - Minimal / (R) Rear Fender, Molding - Scratch - Minimal / Trunk Hood, Rear Gate - Scratch & Dent - Small / Rear Bumper, Lamps, Panels - Scratch - Minimal / (L) Rear Fender, Molding - Scratch - Minimal / (L) Rear Door, Molding - Scratch - Minimal / (L) Front Door, Molding - Scratch - Minimal / Front Bumper, Grille, Lamps - Scratch - Minimal / Bonnet, Headlight - Scratch - Minimal / Roof - Scratch - Minimal |

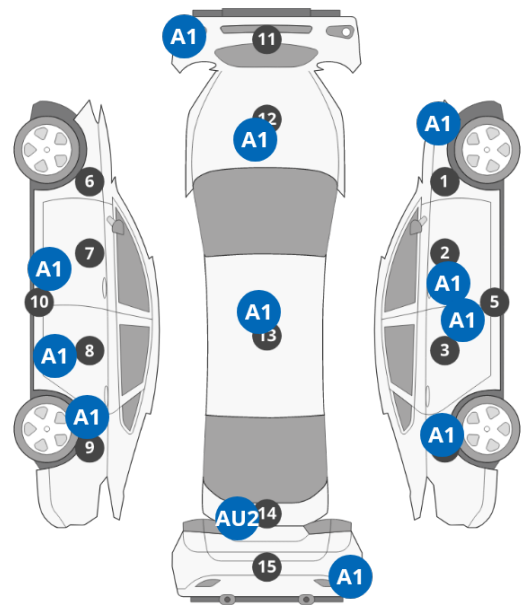
| Inspector Notes |
|---|
| with LTO plate, no warranty booklet, with jack ,Incomplete tools, with spare tire, asphalt splatter on rear bumper |
