## General Information

| Make | Toyota | Model | Vios |
| Registration No. | DAS5899 | Chassis No. | PA1B18F32N4193049 |

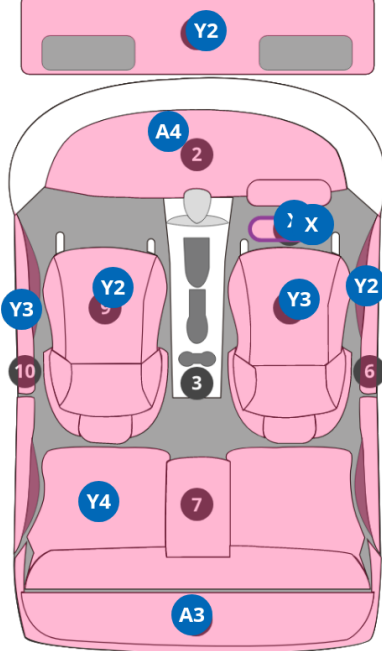
| Interior Evaluation : <span style="color: red;">C</span> | Exterior Evaluation : <span style="color: red;">C</span> |
|---|---|
| <p><b>Remarks</b></p> <p>(L) Front Seat - Grime - Small / (L) Front Trim - Grime - Medium / (R) Front Seat - Grime - Medium / Dashboard - Worn, Scratch, Cut, Crack - Large / Rear Seat - Grime - Large / (L) Front Floor Mat - Missing - Yes / (R) Front Floor Mat - Missing - Yes / Mat Other - Missing - Yes / Trunk Room - Worn, Scratch, Cut, Crack - Medium / (R) Front Trim - Grime - Small / Ceiling - Grime - Small</p> | <p><b>Remarks</b></p> <p>Trunk Hood, Rear Gate - Dent - Medium / Rear Bumper, Lamps, Panels - Scratch - Large / (L) Step, In-panel, Side Spoiler - Scratch - Small / (L) Rear Door, Molding - Scratch - Small / (L) Front Door, Molding - Scratch &amp; Dent - Small / Front Bumper, Grille, Lamps - Crack, Gap - Large / (R) Rear Door, Molding - Scratch &amp; Dent - Small / (R) Front Door, Molding - Scratch - Small / (R) Step, In-panel, Side Spoiler - Scratch - Small / (R) Rear Fender, Molding - Dent - Minimal / (L) Rear Fender, Molding - Scratch - Minimal / (R) Front Fender, Molding - Scratch - Minimal</p> |
