## General Information

| Make | Toyota | Model | Vios |

## Body / Panel Condition

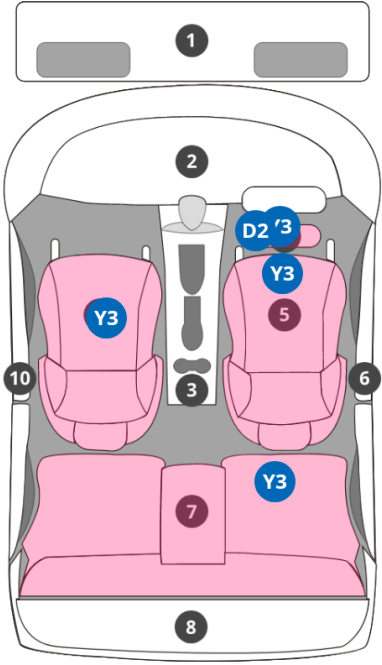
| Interior Evaluation : <b>B</b> | Exterior Evaluation : <b>E</b> |
|---|---|
| <p><b>Remarks</b></p> <p>(R) Front Seat - Grime - Medium / Rear Seat - Grime - Medium / Mat Other - Grime - Medium / (L) Front Seat - Grime - Medium / (L) Front Floor Mat - Worked - Small</p> | <p><b>Remarks</b></p> <p>Member (Bolted) - Dent - Yes / Front Bumper, Grille, Lamps - Scratch &amp; Dent - Large / Bonnet, Headlight - Scratch &amp; Dent - Medium / (R) Rear Door, Molding - Scratch &amp; Dent - Large / (R) Rear Fender, Molding - Scratch &amp; Dent - Large / (R) Front Door, Molding - Scratch &amp; Dent - Small / (L) Front Door, Molding - Scratch &amp; Dent - Medium / (L) Rear Door, Molding - Scratch - Medium / (L) Rear Fender, Molding - Scratch &amp; Dent - Small / Rear Bumper, Lamps, Panels - Scratch &amp; Dent - Medium / Trunk Hood, Rear Gate - Scratch - Small / (L) Front Fender, Molding - Scratch &amp; Dent - Small / (R) Mirror - Scratch - Minimal / (L) Mirror - Scratch - Minimal</p> |

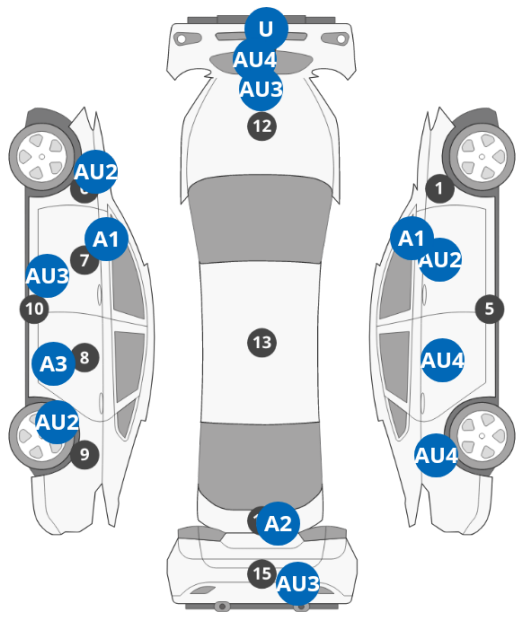
Gap at front bumper and bonnet. Left parklight issue. Bonnet cannot fully open. With warranty booklet, spare tire, jack and incomplete tools. With LTO plate.
