## General Information

| Make | Toyota | Model | Vios |
| Registration No. | NHI7010 | Chassis No. | PA1B18F32P4209477 |

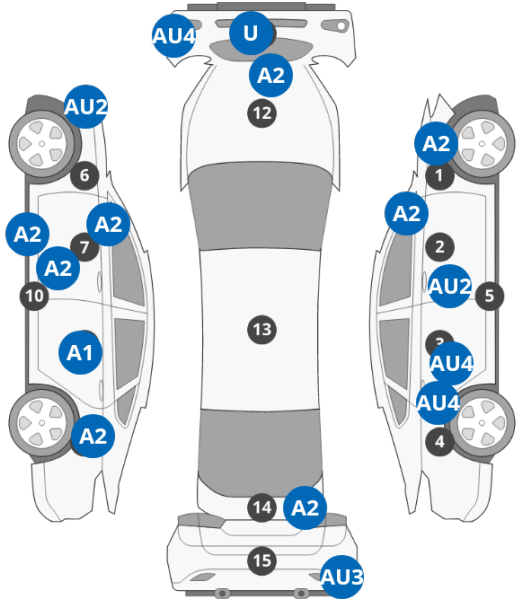
| <b>Remarks</b><br>(R) Front Trim - Grime - Minimal / (L) Front Trim - Grime - Small / (R) Front Seat - Worn - Yes / Overall Interior - Animal Hair - Yes / Ceiling - Grime - Minimal | <b>Remarks</b><br>(R) Rear Door - Repair Traces - Yes / (R) Mirror - Scratch - Small / (R) Front Fender, Molding - Scratch - Small / (R) Front Door, Molding - Scratch & Dent - Small / (R) Rear Door, Molding - Scratch & Dent - Large / (R) Rear Fender, Molding - Scratch & Dent - Large / Rear Bumper, Lamps, Panels - Scratch & Dent - Medium / Trunk Hood, Rear Gate - Scratch - Small / (L) Rear Fender, Molding - Scratch - Small / (L) Rear Door, Molding - Scratch - Minimal / (L) Step, In-panel, Side Spoiler - Scratch - Small / (L) Mirror - Scratch - Small / (L) Front Door, Molding - Scratch - Small / (L) Front Fender, Molding - Scratch & Dent - Small / Front Bumper, Grille, Lamps - Scratch & Dent - Large / Member (Bolted) - Dent - Yes / Bonnet, Headlight - Scratch - Small |

| no warranty booklet, with jack and tools, with spare tire, with LTO plate, crack left headlight, scratch on left tail light, battery weak, power steering issue due to weak battery |
