## General Information

| Make | Toyota | Model | Vios |

## Body / Panel Condition

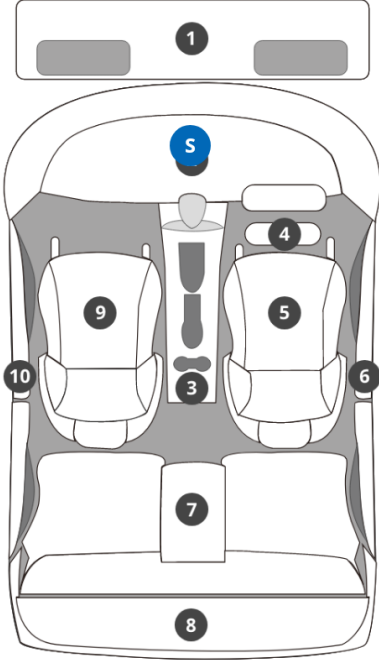
| Interior Evaluation : <b>B</b> | Exterior Evaluation : <b>E</b> |
|---|---|
| <b>Remarks</b><br>Overall Interior - Smell - Yes | <b>Remarks</b><br>(L) Front Fender - Repair Traces - Yes / Rear Bumper, Lamps, Panels - Scratch & Dent - Large / Trunk Hood, Rear Gate - Scratch & Dent - Large / (L) Rear Fender, Molding - Scratch & Dent - Large / Bonnet, Headlight - Scratch - Large / Front Bumper, Grille, Lamps - Scratch - Large / (R) Front Fender, Molding - Scratch - Medium / (R) Front Door, Molding - Scratch - Medium / (R) Rear Fender, Molding - Scratch - Medium |
