## General Information

| Make | Toyota | Model | Vios |
| YOM | 2024 | Mileage | 9,458 |
| Registration No. | NHM9219 | Chassis No. | PA1B18F33R4243933 |

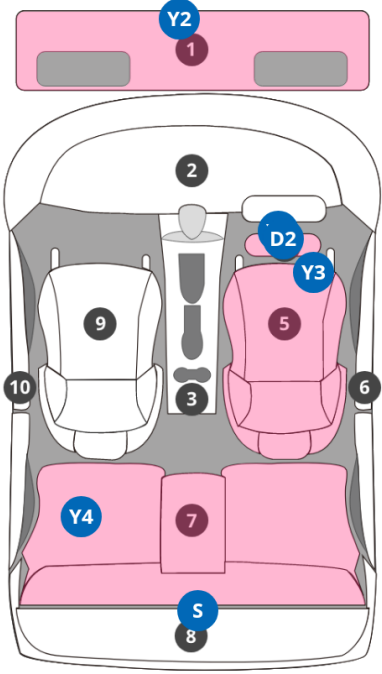
| Interior Evaluation : <span style="color: red;">C</span> | Exterior Evaluation : <span style="color: red;">E</span> |
|---|---|
| <p><b>Remarks</b><br/>Rear Seat - Grime - Large / (R) Front Seat - Grime - Medium / (R) Front Floor Mat - Grime - Small / (L) Front Floor Mat - Worked - Small / Ceiling - Grime - Small / Overall Interior - Smell - Yes</p> | <p><b>Remarks</b><br/>(R) Mirror - Scratch - Small / (R) Rear Door, Molding - Scratch - Small / (R) Front Door, Molding - Scratch &amp; Dent - Minimal / (R) Step, In-panel, Side Spoiler - Scratch &amp; Dent - Large / (R) Rear Fender, Molding - Scratch &amp; Dent - Large / Rear Bumper, Lamps, Panels - Scratch - Large / Trunk Hood, Rear Gate - Scratch - Medium / (L) Rear Door, Molding - Scratch - Small / (L) Front Door, Molding - Scratch - Small / (L) Rear Fender, Molding - Scratch - Small / (L) Mirror - Scratch - Minimal / Front Bumper, Grille, Lamps - Scratch &amp; Dent - Medium / Roof - Scratch - Medium</p> |
