## General Information

| Make | Toyota | Model | Vios |

## Body / Panel Condition

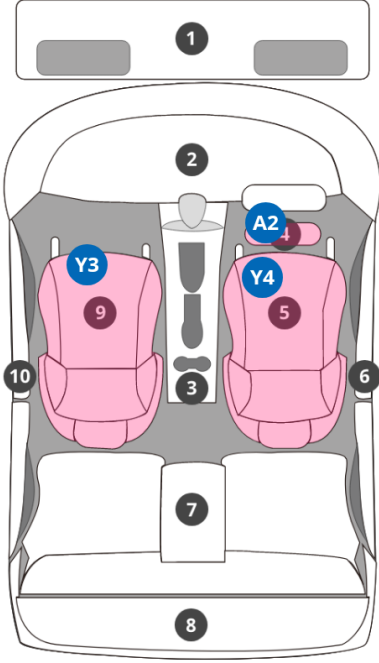
| Interior Evaluation : <span style="color: red;">C</span> | Exterior Evaluation : <span style="color: red;">B</span> |
| <b>Remarks</b><br>(R) Front Seat - Grime - Large / (L) Front Seat - Grime - Medium / (L) Front Floor Mat - Cut, Crack - Small | <b>Remarks</b><br>Front Bumper, Grille, Lamps - Scratch - Small / (L) Front Door, Molding - Scratch - Minimal / (L) Step, In-panel, Side Spoiler - Scratch - Minimal / (L) Rear Fender, Molding - Scratch - Small / (L) Rear Door, Molding - Scratch - Minimal / Rear Bumper, Lamps, Panels - Scratch - Minimal / Trunk Hood, Rear Gate - Scratch - Minimal / (R) Rear Fender, Molding - Scratch - Medium / (R) Rear Door, Molding - Scratch - Small / Bonnet, Headlight - Scratch - Minimal |
