## General Information

| Make | Toyota | Model | Avanza |

## Body / Panel Condition

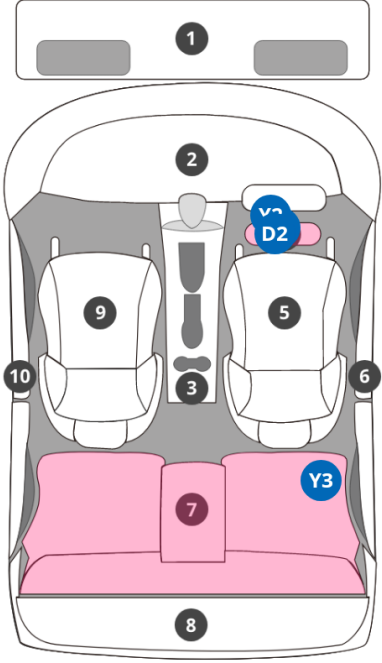
| Interior Evaluation : <b>A</b> | Exterior Evaluation : <b>C</b> |
| <p><b>Remarks</b><br/>Mat Other - Grime - Small / (R) Front Floor Mat - Grime - Small / (L) Front Floor Mat - Worked - Small</p> | <p><b>Remarks</b><br/>(R) Front Fender, Molding - Scratch - Minimal / (R) Mirror - Scratch - Minimal / (R) Front Door, Molding - Scratch - Small / (R) Rear Door, Molding - Scratch - Minimal / (R) Rear Fender, Molding - Scratch - Small / Rear Bumper, Lamps, Panels - Scratch - Large / (L) Rear Fender, Molding - Scratch - Small / (L) Rear Door, Molding - Scratch &amp; Dent - Medium / (L) Front Door, Molding - Scratch &amp; Dent - Small / (L) Mirror - Scratch - Small / Front Bumper, Grille, Lamps - Scratch &amp; Dent - Medium / Bonnet, Headlight - Scratch &amp; Dent - Minimal</p> |
