## General Information

| Make | Toyota | Model | Vios |

## Body / Panel Condition

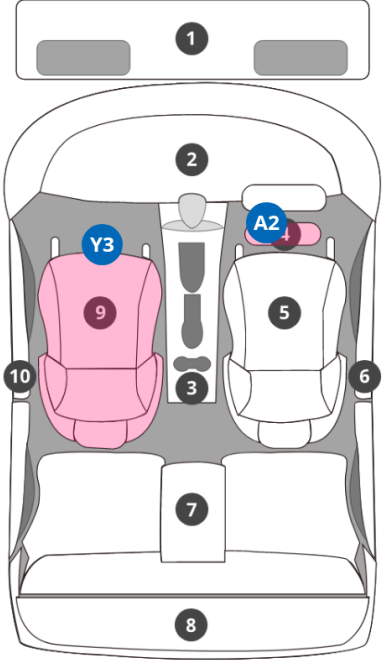
| Interior Evaluation : <b>B</b> | Exterior Evaluation : <b>C</b> |
|---|---|
| <b>Remarks</b><br>(L) Front Seat - Grime - Medium / (L) Front Floor Mat - Cut, Crack - Small | <b>Remarks</b><br>Rear Bumper, Lamps, Panels - Scratch & Dent - Large / Bonnet, Headlight - Dent - Small / Front Bumper, Grille, Lamps - Scratch - Large / (R) Front Door, Molding - Dent - Small / (R) Rear Door, Molding - Dent - Small / (L) Front Door, Molding - Dent - Small |

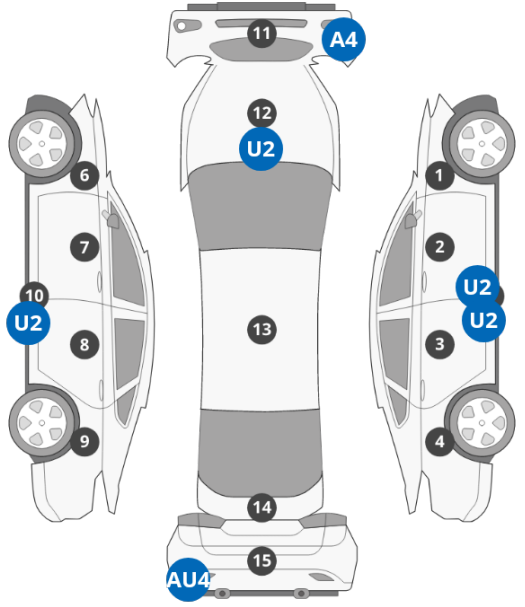
| Inspector Notes |
|---|
| with spare tire and jack/ with LTO plate/ incomplete tools/ no warranty booklet / broken right tail light/ no low beam/ power steering issue due to low battery/ |
