## General Information

| Make | Toyota | Model | Vios |

## Body / Panel Condition

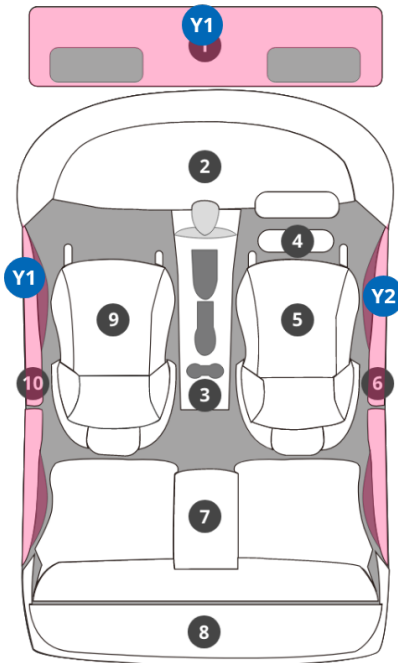
| Interior Evaluation : <b>A</b> | Exterior Evaluation : <b>C</b> |
| <p><b>Remarks</b><br/>(L) Front Trim - Grime - Minimal / Ceiling - Grime - Minimal / (R) Front Trim - Grime - Small</p> | <p><b>Remarks</b><br/>Bonnet - Repair Traces - Yes / (L) Front Fender - Repair Traces - Yes / Member (Bolted) - Rust, Corrosion - Yes / (L) Front Fender, Molding - Repair mark - Yes / Bonnet, Headlight - Repair mark - Yes / Rear Bumper, Lamps, Panels - Repair mark - Yes / Rear Bumper, Lamps, Panels - Scratch - Medium / Trunk Hood, Rear Gate - Scratch - Small / (L) Rear Door, Molding - Dent - Minimal / (L) Front Door, Molding - Scratch - Minimal / (R) Front Fender, Molding - Scratch - Medium / Front Bumper, Grille, Lamps - Scratch - Large / (R) Front Door, Molding - Scratch - Minimal / (R) Mirror - Scratch - Minimal / (R) Rear Door, Molding - Scratch - Small / (R) Rear Fender, Molding - Scratch - Minimal</p> |
