## General Information

| Make | Toyota | Model | Vios |

## Body / Panel Condition

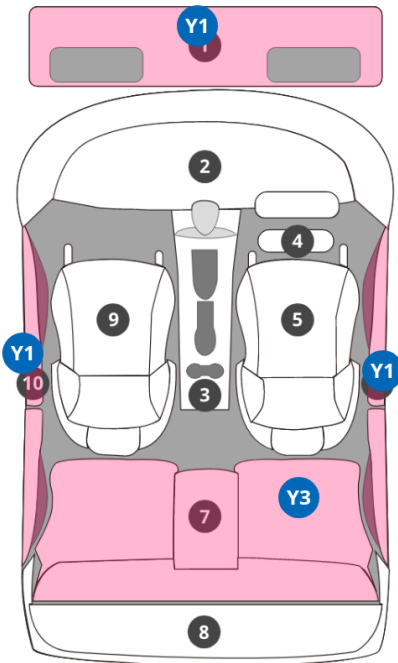
| <b>Interior Evaluation :</b> <b>B</b> | <b>Exterior Evaluation :</b> <b>B</b> |
| <b>Remarks</b><br>(L) Front Trim - Grime - Minimal / (R) Front Trim - Grime - Minimal / Ceiling - Grime - Minimal / Rear Seat - Grime - Medium | <b>Remarks</b><br>(R) Front Fender, Molding - Scratch - Minimal / (R) Front Door, Molding - Scratch - Minimal / (R) Rear Fender, Molding - Scratch - Minimal / Rear Bumper, Lamps, Panels - Scratch - Small / Trunk Hood, Rear Gate - Scratch - Minimal / (L) Rear Fender, Molding - Scratch - Minimal / (L) Rear Door, Molding - Scratch - Minimal / (L) Front Door, Molding - Scratch - Minimal / Front Bumper, Grille, Lamps - Scratch - Minimal / Bonnet, Headlight - Scratch - Minimal / (R) Rear Door, Molding - Scratch - Minimal / Roof - Scratch - Minimal |
