## General Information

| Make | Toyota | Model | Vios |

## Body / Panel Condition

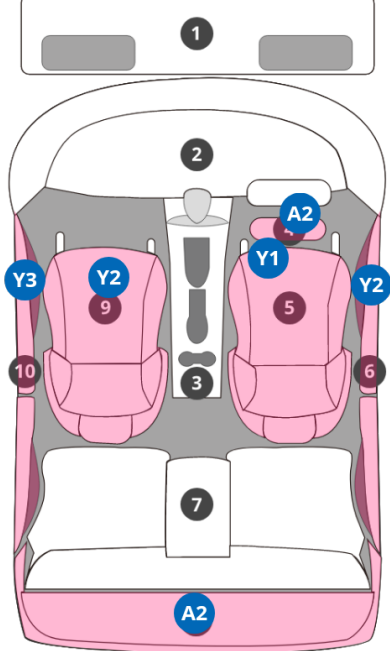
| Interior Evaluation : <b>B</b> | Exterior Evaluation : <b>E</b> |
| <b>Remarks</b><br>(R) Front Seat - Grime - Minimal / (R) Front Trim - Grime - Small / Trunk Room - Worn, Scratch, Cut, Crack - Small / (L) Front Floor Mat - Cut, Crack - Small / (L) Front Seat - Grime - Small / (L) Front Trim - Grime - Medium | <b>Remarks</b><br>(R) Rear Fender, Molding - Scratch & Dent - Large / (R) Rear Door, Molding - Scratch - Small / Trunk Hood, Rear Gate - Scratch - Small / (L) Rear Fender, Molding - Scratch & Dent - Minimal / (L) Rear Door, Molding - Scratch & Dent - Small / (L) Front Door, Molding - Scratch - Medium / (L) Front Fender, Molding - Dent - Small / Front Bumper, Grille, Lamps - Scratch - Large / (R) Front Fender, Molding - Scratch & Dent - Large / Bonnet, Headlight - Scratch - Minimal / (R) Front Door, Molding - Scratch - Small / (R) Step, In-panel, Side Spoiler - Scratch - Large |
