## General Information

| Make | Toyota | Model | Veloz |

## Body / Panel Condition

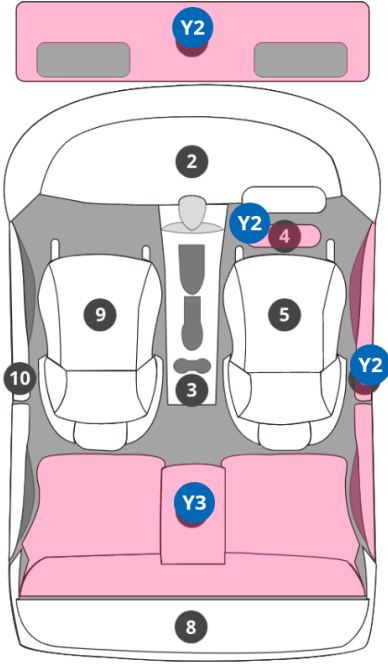
| Interior Evaluation : <span style="color: red;">B</span> | Exterior Evaluation : <span style="color: red;">C</span> |
| <p><b>Remarks</b></p> <p>(R) Front Trim - Grime - Small / Rear Seat - Grime - Medium / Ceiling - Grime - Small / (L) Front Floor Mat - Grime - Small</p> | <p><b>Remarks</b></p> <p>Bonnet, Headlight - Scratch &amp; Dent - Small / (L) Front Fender, Molding - Scratch &amp; Dent - Small / (L) Mirror - Scratch - Small / (L) Rear Fender, Molding - Dent - Small / (L) Front Door, Molding - Scratch - Minimal / Trunk Hood, Rear Gate - Scratch &amp; Dent - Large / (R) Front Door, Molding - Scratch &amp; Dent - Small / (R) Rear Fender, Molding - Dent - Minimal / (R) Mirror - Scratch - Small / Front Bumper, Grille, Lamps - Scratch - Large / Roof - Dent - Small</p> |
