## General Information

| Make | Toyota | Model | Vios |
| Registration No. | NHR6734 | Chassis No. | PA1B18F33P4230211 |

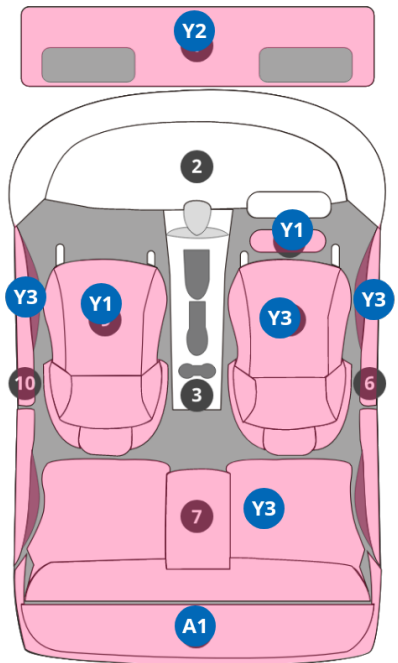
| Interior Evaluation : <span style="color: red;">C</span> | Exterior Evaluation : <span style="color: red;">E</span> |
| <b>Remarks</b><br>(L) Front Floor Mat - Grime - Minimal / (L) Front Seat - Grime - Minimal / (R) Front Seat - Grime - Medium / Rear Seat - Grime - Medium / (R) Front Trim - Grime - Medium / (L) Front Trim - Grime - Medium / Ceiling - Grime - Small / Trunk Room - Worn, Scratch, Cut, Crack - Minimal | <b>Remarks</b><br>Trunk Hood, Rear Gate - Scratch & Dent - Medium / Rear Bumper, Lamps, Panels - Scratch - Large / (R) Rear Fender, Molding - Scratch - Medium / (R) Rear Door, Molding - Scratch - Small / (R) Front Door, Molding - Scratch - Medium / (R) Front Fender, Molding - Scratch - Minimal / Front Bumper, Grille, Lamps - Scratch - Small / (L) Front Fender, Molding - Scratch - Large / (L) Rear Door, Molding - Scratch - Medium / (L) Front Door, Molding - Crack, Gap - Small / (L) Rear Fender, Molding - Scratch - Minimal / Roof - Dent - Small / Bonnet, Headlight - Scratch - Minimal |
