## General Information

| Make | Toyota | Model | Vios |
| YOM | 2024 | Mileage | 21,789 |
| Registration No. | NHS1110 | Chassis No. | PA1B18F36P4234009 |

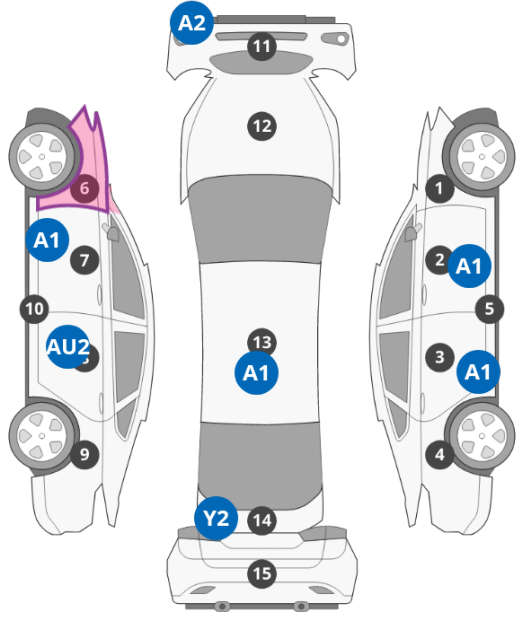
| Interior Evaluation : <span style="color: red;">A</span> | Exterior Evaluation : <span style="color: red;">B</span> |
| <b>Remarks</b><br>Defects not found | <b>Remarks</b><br>(L) Front Wheel, Cover - Cap Missing - Yes / Front Bumper, Grille, Lamps - Scratch - Small / (L) Front Door, Molding - Scratch - Minimal / Roof - Scratch - Minimal / (L) Rear Door, Molding - Scratch & Dent - Small / Trunk Hood, Rear Gate - Crack, Gap - Small / (R) Front Door, Molding - Scratch - Minimal / (R) Rear Door, Molding - Scratch - Minimal |

missing front left wheel cap/ with LTO plate and warranty booklet/ with tools and jack/with spare tire / no horn
