## General Information

| Make | Toyota | Model | Vios |
| YOM | 2024 | Mileage | 21,619 |

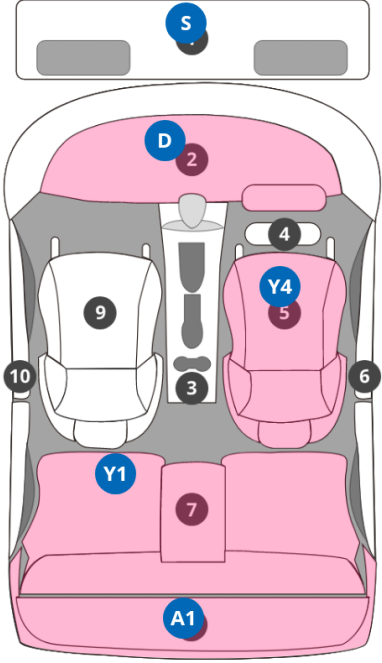
| <b>Interior Evaluation :</b> <span style="color: red; font-weight: bold;">C</span> | <b>Exterior Evaluation :</b> <span style="color: red; font-weight: bold;">C</span> |
| <b>Remarks</b><br>(R) Front Seat - Grime - Large / Rear Seat - Grime - Minimal / Trunk Room - Worn, Scratch, Cut, Crack - Minimal / Dashboard - Traces of Adhesive Tape - Yes / Overall Interior - Smell - Yes | <b>Remarks</b><br>(R) Front Door - Repair Traces - Yes / (R) Front Fender - Repair Traces - Yes / Bonnet - Repair Traces - Yes / (L) Front Fender - Repair Traces - Yes / (L) Front Door - Repair Traces - Yes / (R) Front Fender, Molding - Repair mark - Yes / Bonnet, Headlight - Repair mark - Yes / (R) Front Door, Molding - Repair mark - Yes / (R) Mirror - Scratch - Minimal / (R) Rear Door, Molding - Repair mark - Yes / Rear Bumper, Lamps, Panels - Scratch - Small / Trunk Hood, Rear Gate - Scratch & Dent - Medium / (L) Rear Fender, Molding - Scratch - Minimal / (L) Rear Door, Molding - Scratch - Minimal / (L) Front Door, Molding - Scratch - Minimal / Front Bumper, Grille, Lamps - Scratch & Dent - Large / Roof - Scratch - Minimal |
