## General Information

| Make | Toyota | Model | Wigo |
| YOM | 2020 | Mileage | 43,750 |
| Registration No. | NGL1674 | Chassis No. | MHKA4DE5EKJD38613 |

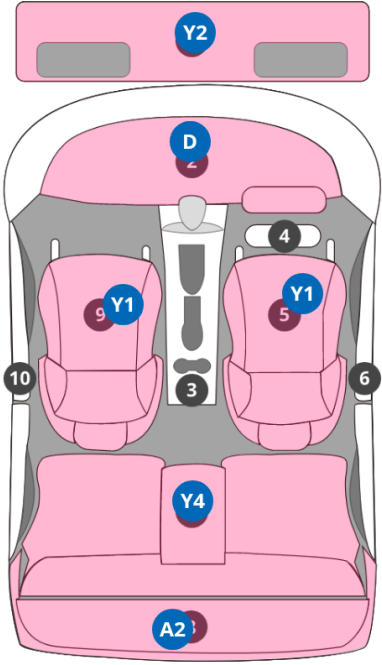
| Interior Evaluation : <span style="color: red;">C</span> | Exterior Evaluation : <span style="color: red;">E</span> |
| <b>Remarks</b><br>Dashboard - Traces of Adhesive Tape - Yes / Rear Seat - Grime - Large / (R) Front Seat - Grime - Minimal / Trunk Room - Worn, Scratch, Cut, Crack - Small / Ceiling - Grime - Small / (L) Front Seat - Grime - Minimal | <b>Remarks</b><br>(L) Rear Fender, Molding - Dent - Medium / (L) Rear Door, Molding - Scratch & Dent - Large / (L) Front Door, Molding - Scratch & Dent - Small / (L) Mirror - Scratch - Minimal / (L) Front Fender, Molding - Scratch - Small / Bonnet, Headlight - Scratch - Minimal / (R) Front Fender, Molding - Scratch & Dent - Medium / Front Bumper, Grille, Lamps - Crack, Gap - Large / (R) Mirror - Scratch - Small / (R) Front Door, Molding - Scratch & Dent - Medium / (R) Rear Door, Molding - Scratch - Large / (R) Rear Fender, Molding - Scratch & Dent - Medium / Trunk Hood, Rear Gate - Dent - Small / Rear Bumper, Lamps, Panels - Scratch - Large / Roof - Dent - Small |
