## General Information

| Make | Toyota | Model | Vios |
| YOM | 2023 | Mileage | 20,528 |
| Registration No. | NIG3842 | Chassis No. | PA1B18F3XN4198435 |

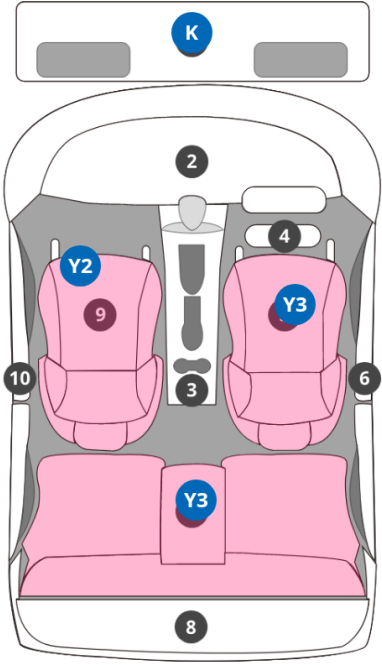
| Interior Evaluation : <b>B</b> | Exterior Evaluation : <b>C</b> |
|---|---|
| <b>Remarks</b><br>(R) Front Seat - Grime - Medium / Overall Interior - Animal Hair - Yes / Rear Seat - Grime - Medium / (L) Front Seat - Grime - Small | <b>Remarks</b><br>(L) Front Fender - Repair Traces - Yes / Member (Bolted) - Dent - Yes / (R) Rear Door, Molding - Scratch - Medium / Rear Bumper, Lamps, Panels - Scratch - Small / (R) Front Fender, Molding - Scratch - Small / Front Bumper, Grille, Lamps - Scratch & Dent - Large / (R) Mirror - Scratch - Minimal / (L) Front Fender, Molding - Scratch - Small |
